**Report of the Task Force on
Investigation of Excessive
Lead Content in Drinking Water**

October 2015

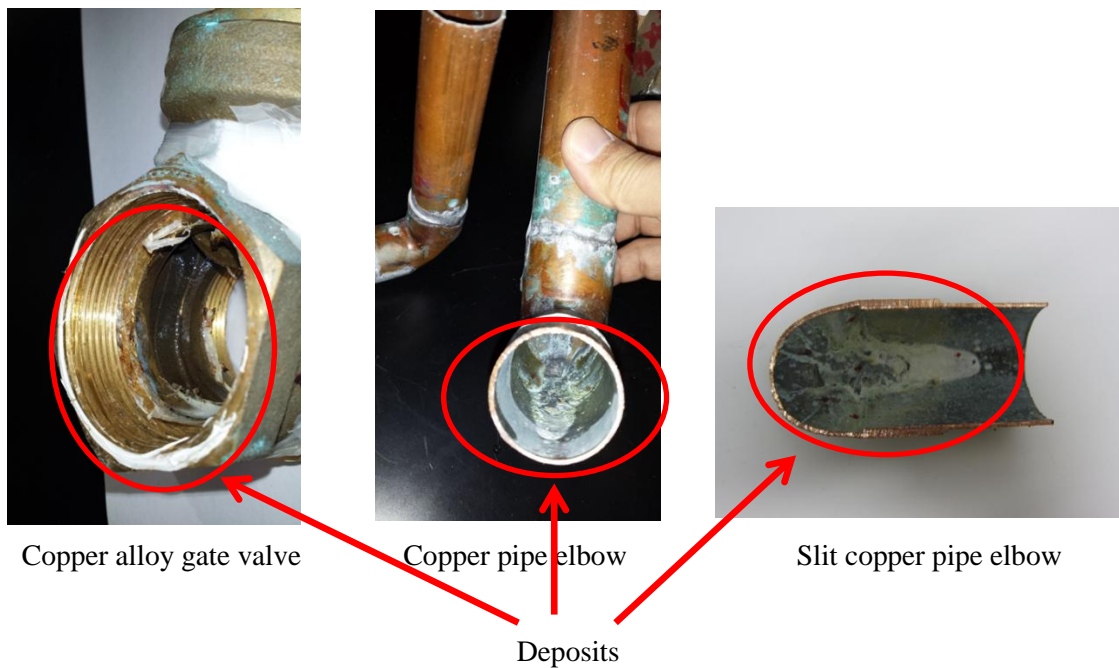
Figure 2.5 Deposits in copper alloy valve and copper pipe elbows

2.5.3 On examination, deposits of various amounts were found inside the components of pipes and fittings in the branch pipes as shown in the photos in **Figure 2.5**. It was believed that there were lead containing compounds which might release lead into the drinking water.

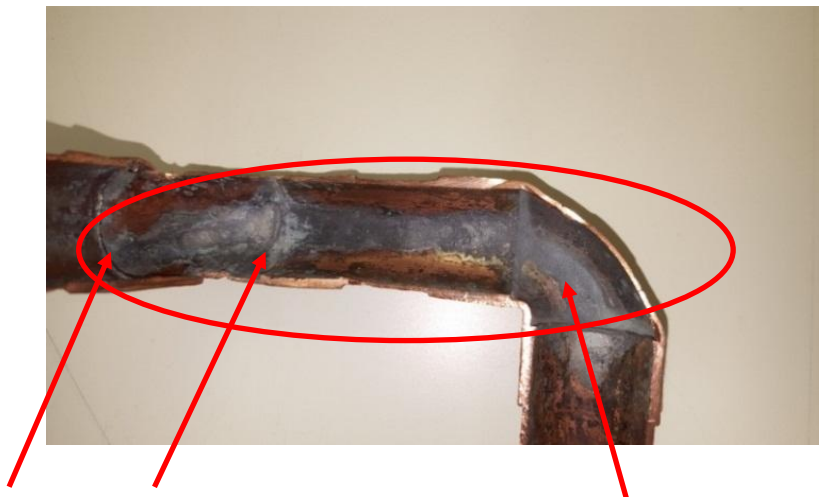
Leaded solder joints

2.5.10 Similarly, solder joints still leached lead after cleansing the deposits although the leached amounts had been reduced. The elemental analysis showed that the lead contents of the solder in most of the joints tested were between 33% and 41% which were well above the limit for lead-free solder stipulated in the BS¹² of 0.07%. The Task Force therefore considered that lead leaching also occurred in the solder joints. A photo of leaded solder joint is shown in **Figure 2.6** below.

Solder materials seeped into the pipe due to poor workmanship by overheating for an extended period of time and/or applying excessive solder.

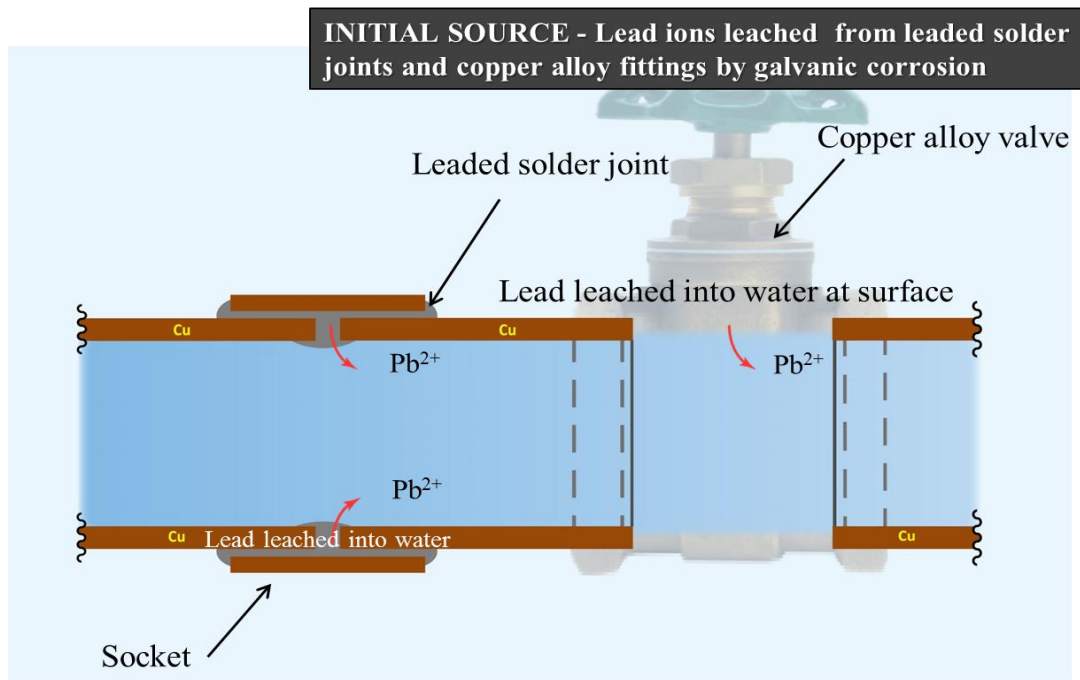
Figure 2.8(a) Leaching of lead from leaded solder joints and copper alloy fittings

2.8.1 The mechanism for lead leaching from copper alloy fittings and leaded solder joints in contact with water is the formation of a corrosion cell between the lead and the copper resulting in galvanic corrosion. Under this setting, copper acts as the cathode metal, lead acts as the anode metal and water is the electrolyte medium. As lead has a greater tendency to lose electrons to form positive ions than does copper, lead ions leach into water as a result of galvanic corrosion and the process is shown in **Figure 2.7**.

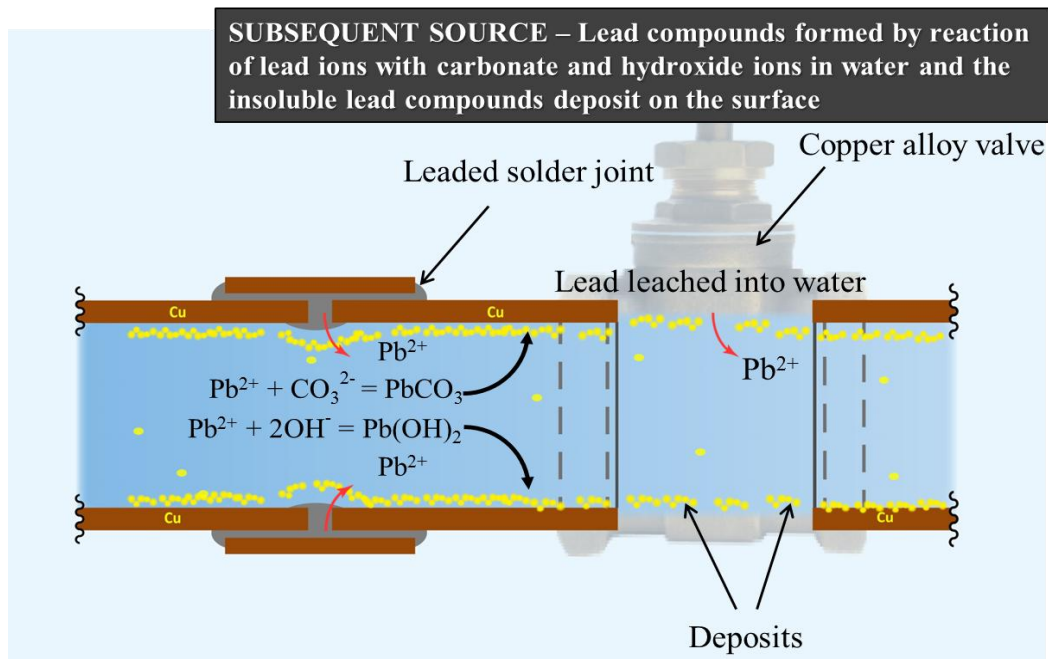
Figure 2.8(b) Formation of lead containing deposits

2.8.2 Reaction of lead ions with carbonate ions and hydroxide ions in water may form insoluble lead carbonates or lead hydroxides at or near the surfaces where lead ions are released due to the low solubilities of the carbonates and hydroxides and the relatively higher concentrations of the lead ions under stagnant conditions. The insoluble compounds may deposit locally or be drifted downstream and deposit on other surfaces in contact as alien matters. The formation of lead compounds was identified by

analysis of the deposits cleansed from some of the components of the water supply chains. The test results shown in **Annex 2.5** indicated the presence of lead compounds in the deposits which could also release lead into the drinking water by dissolution as lead ions and by suspension as small particles of lead compounds from the deposits. **Figure 2.8 (a)-(c)** illustrates the process of formation of lead containing deposits and release of lead into drinking water from the deposits.

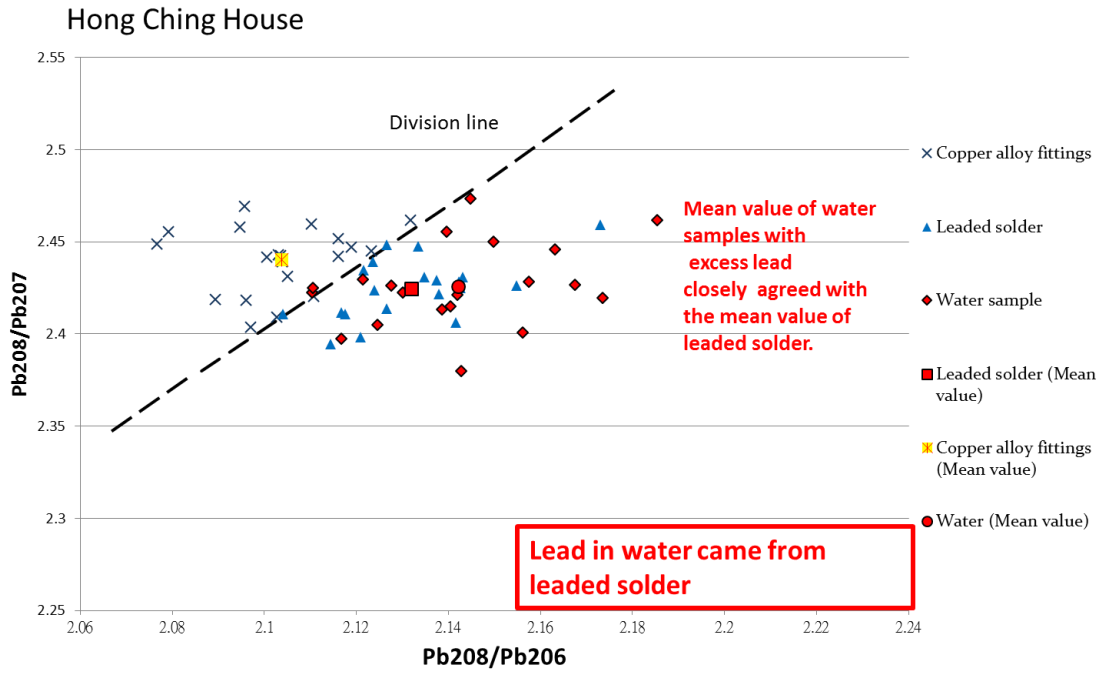
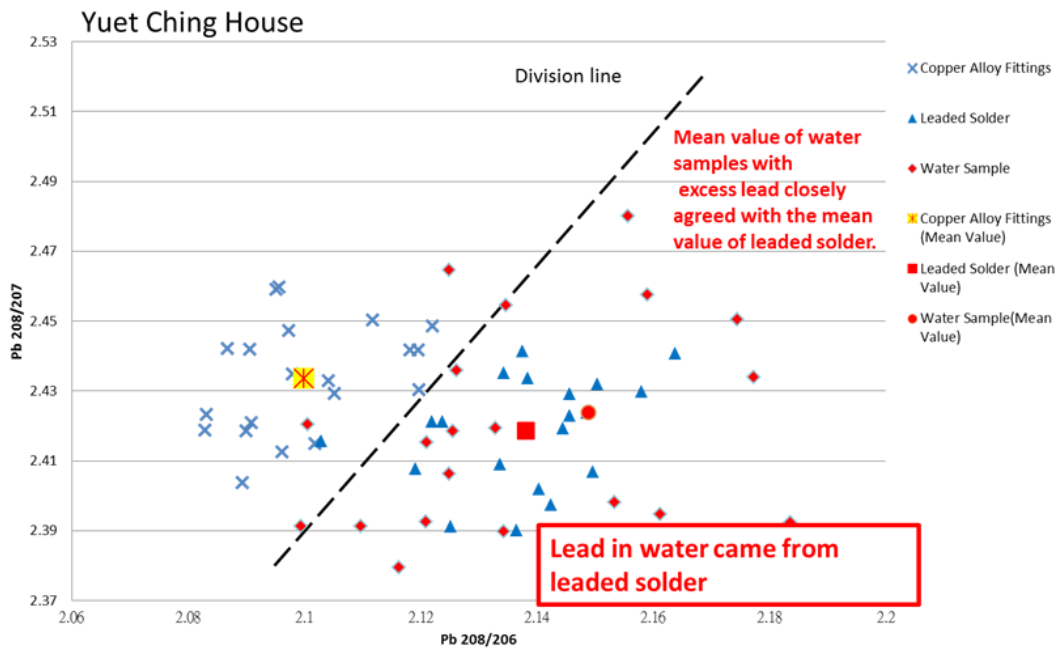
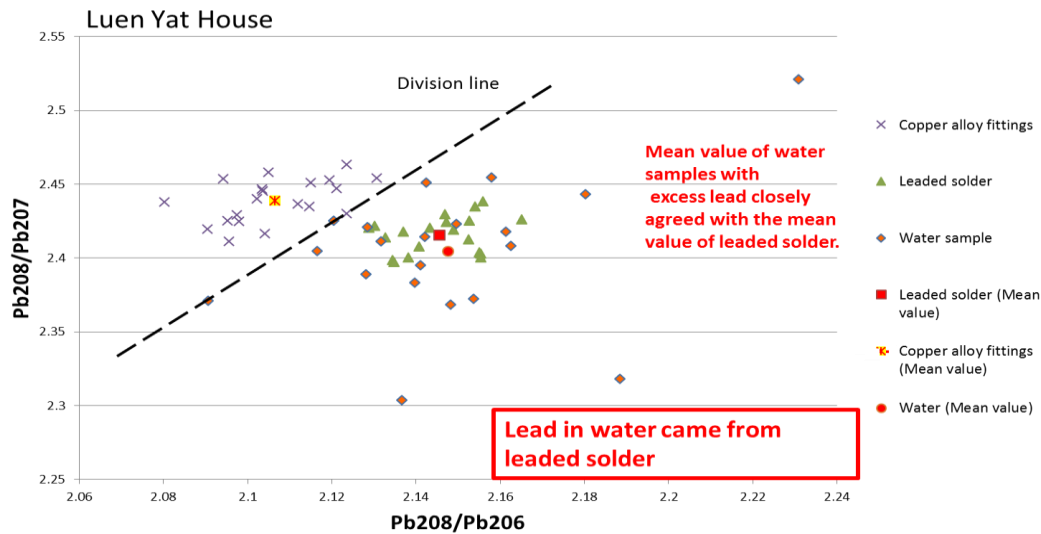
- 2.9.6 Results of the isotopic analysis for the three water supply chains are shown in **Figures 2.9-2.11**. LDA of the lead isotopic ratios of the copper alloy valves and the leaded solder joints showed that they were two separate clusters at 95% confidence level and were significantly different from each other in all three water supply chains.
- 2.9.7 Further analysis of the isotopic ratios of the lead in the water samples showed that their mean values closely agreed with those of the leaded solder joints at 95% confidence level. It was therefore deduced that the lead in drinking water mainly came from the leaded solder joints.

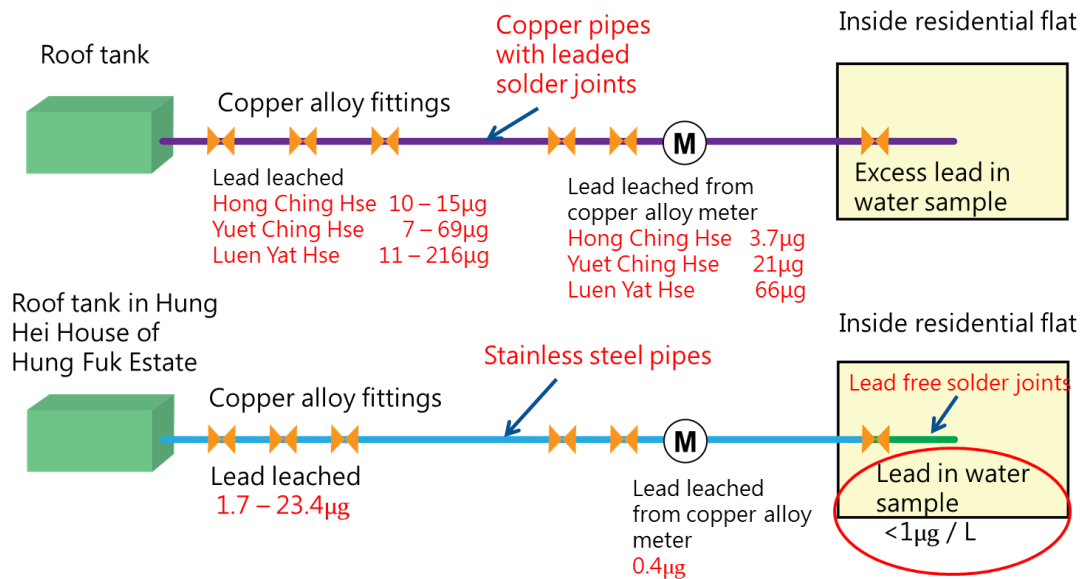
Figure 2.12 Comparison of the control water supply chain in HFE with that of the three water supply chains in KCE and KLE2

2.11.4 Therefore, by comparing the control water supply chain in HFE (without leaded solder joints) with the three water supply chains in KCE and KLE2 (with leaded solder joints) as shown in **Figure 2.12**, it could be confirmed that leaded solder joints should be the cause of excess lead in drinking water and even

though the copper alloy fittings leached lead, they would not result in excess lead contents in drinking water.

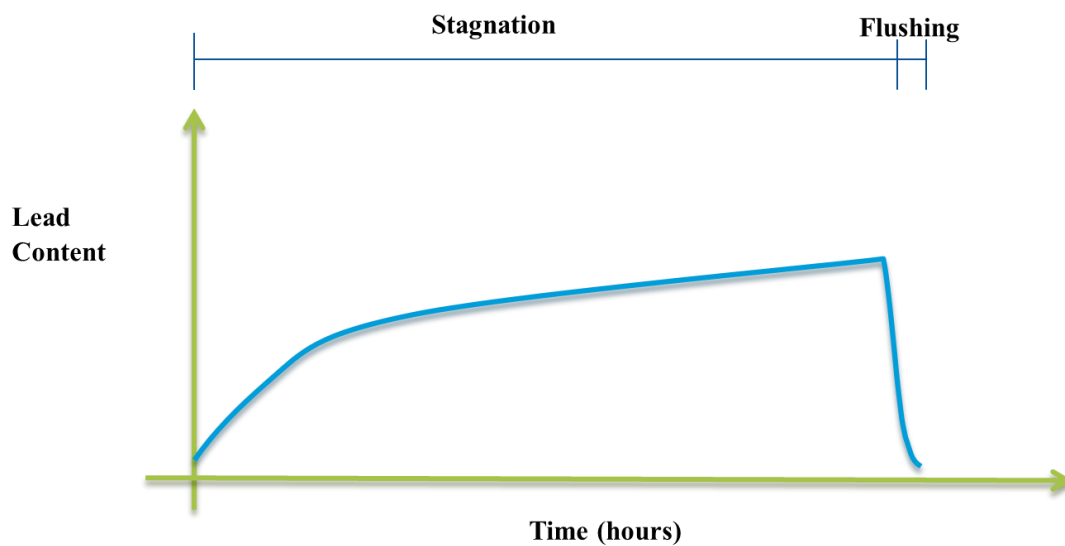
Figure 2.13 Generalised results of stagnation and flushing tests

2.12.4 The results of the stagnation and flushing tests conducted in the three vacant flats and one management office revealed that the lead contents in water would increase with its stagnation time in the water supply chain if there was lead leaching from its components. In addition, the test results also indicated that the lead contents in the stagnated water could be reduced substantially after flushing for about two minutes. The test results are illustrated in **Figure 2.13** below and a combined graph is presented in **Annex 2.9**.

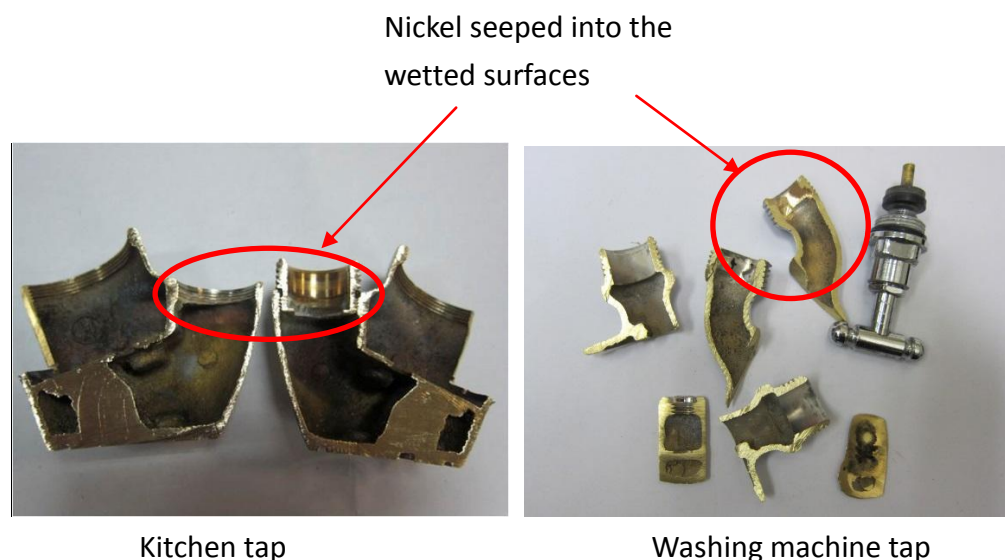
Figure 3.1 Cross-section of taps

3.3.1 The leaching test results for chromium, cadmium and nickel from the various components of pipes and fittings in the three water supply chains in KCE and KLE2 are shown in **Annexes 2.3(a)-(c)**. Based on the leaching test results, the amounts of chromium and cadmium leached from the various components were low. However, there was significant leaching of nickel from some taps in KCE, e.g. the highest leached amount of nickel after standing for 24 hours was 102.0µg or 1,569µg/L in one washing machine tap. Elemental analysis on the cross section of these taps showed that nickel had seeped into the wetted surfaces of the taps during electroplating (**Figure 3.1**). Nevertheless, as the taps hold very small amounts of water (less than 150ml) under stagnant condition, the leached nickel should be flushed away within one to two seconds after turning on the taps.
