**Investigation Report on
the Incident of Unpleasant Odour
in Drinking Water
in Kwai Chung and Tsuen Wan**

January 2018

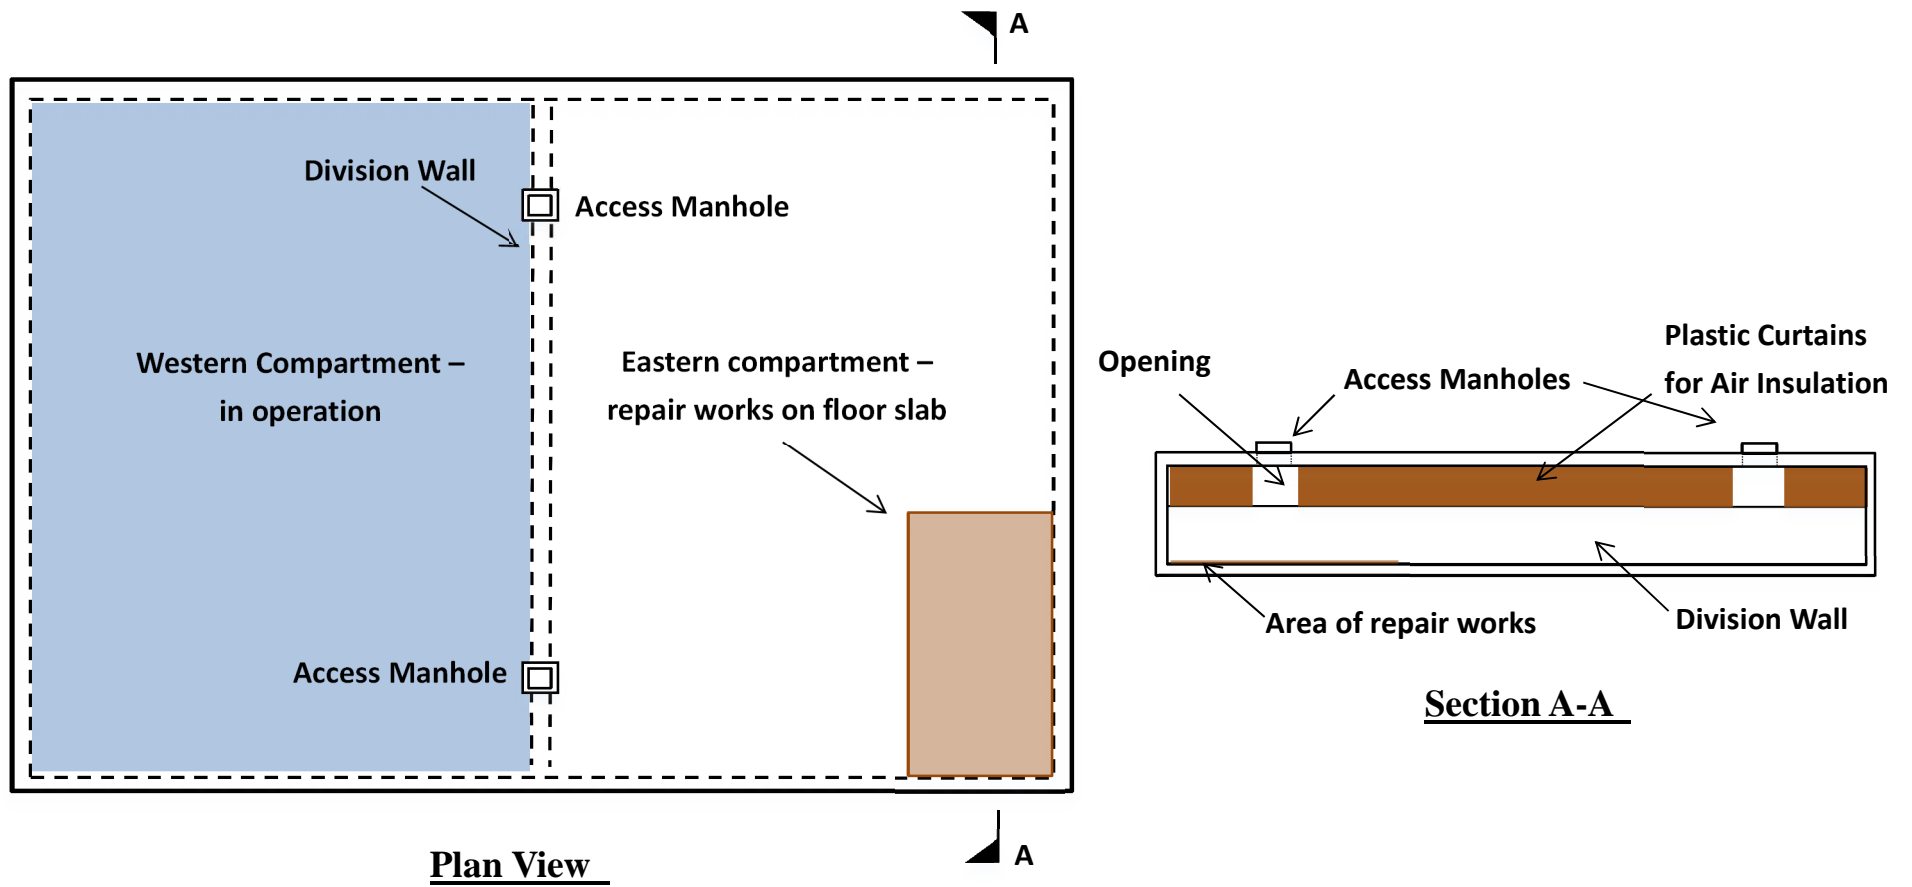
Figure 2 – General layout of Tsuen Wan Fresh Water Service Reservoir

2.3.1 The TWFWSR is a service reservoir built in 1957 with two compartments, which are separated by a concrete division wall. Such design is conventional which allows one compartment to be in operation to supply water while maintenance works are being carried out at the other compartment in order to maintain the reliability of the water supply system. As the division wall is about 2.5 metres lower than the ceiling of the service reservoir, there is a gap between the top of the division wall and

the ceiling of the service reservoir. Plastic curtains for air insulation have been installed to seal off the gap.

2.3.2 However, the 60-year old TWFWSR is of an old layout design with two access manholes with cat ladders on the top of the division wall to allow access to the service reservoir for carrying out maintenance works. As a result, the gap on top of the division wall at the locations of the access manholes / cat ladders has not been completely sealed off with plastic curtains for air insulation.

- (i) For maintenance works carried out in one compartment of a service reservoir with another compartment in operation for supplying water, all openings between the ceiling of the service reservoir and the division wall should be completely sealed off;

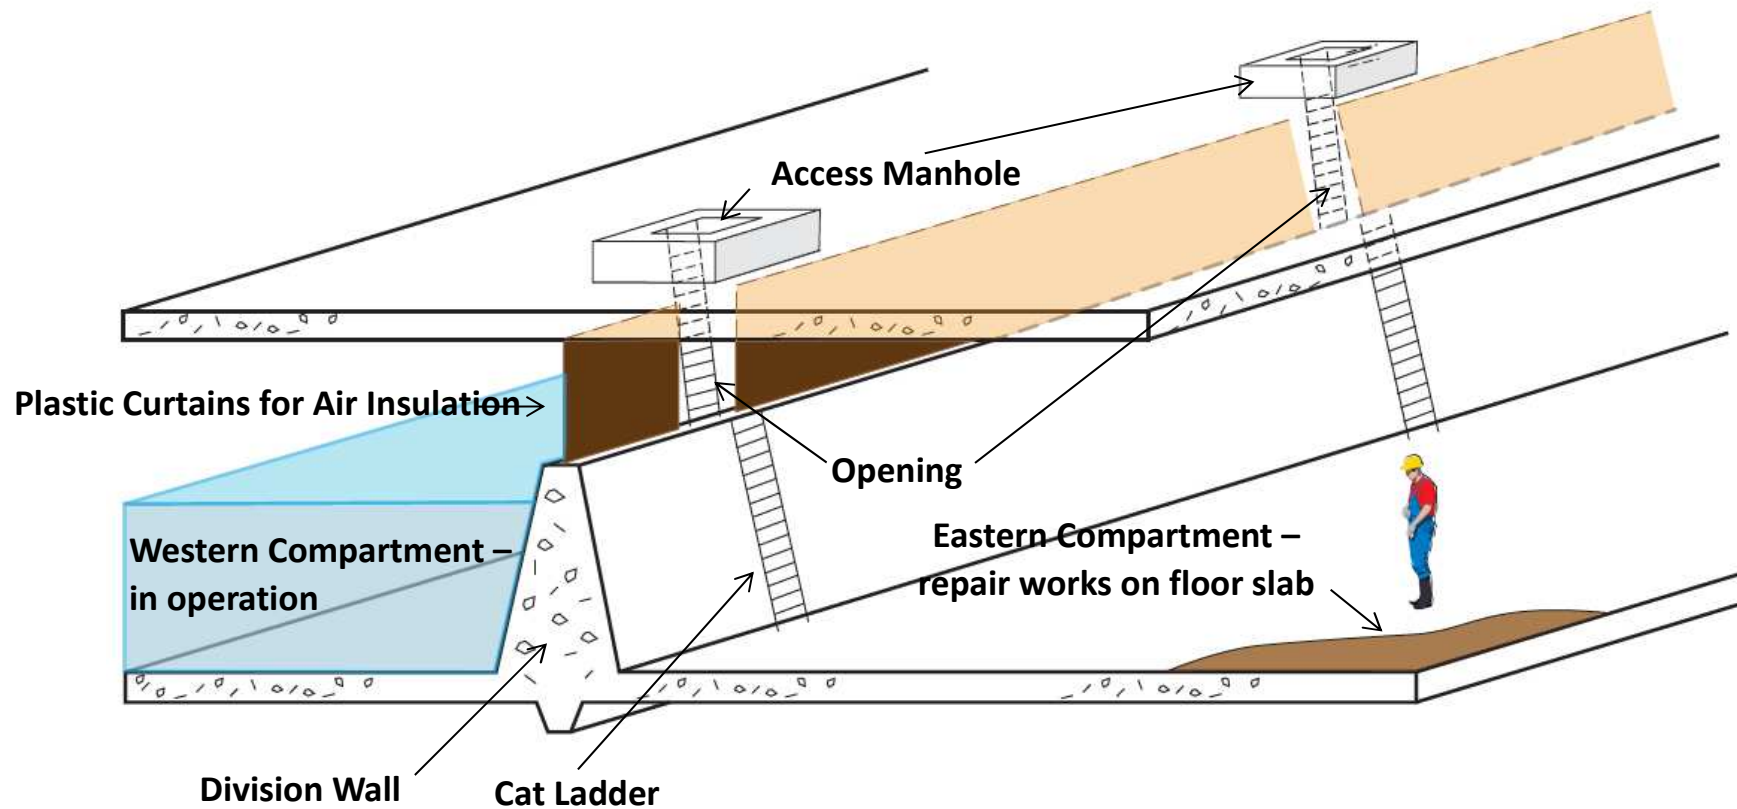
Figure 3 - Schematic arrangement of floor slab repairing works

2.3.4 Maintenance works were carried out at the eastern compartment of the TWFWSR starting in early October 2017 to maintain its durability and water-tightness. The compartment was drained down on 2 October 2017 while the western compartment continued to be in operation for supplying water. The repair works in the eastern compartment, commenced on 7 October 2017, were first to repair the worn-out walls and floor joints by applying epoxy coating (MasterProtect 180) and joint sealant (Polyseal PS) and no complaint on unpleasant odour of drinking water had been received during this period. In the final stage of the maintenance works, a protective coating was to be applied to the worn-out part of the floor slab (about 250 square metres, 16% of the total floor slab area) of the eastern compartment. **Figure 3** shows the schematic arrangement of the maintenance works to the floor slab in the eastern compartment.

2.3.5 The protective coating for applying to the worn-out part of the floor slab of the eastern compartment was SPUA-406. It is a polyurea-based material and is an approved product under the United Kingdom Water Regulations Advisory Scheme (WRAS). The cured protective coating contains no harmful substance to human and complies with the BS6920 for use in potable water installation works. A copy of the approval document is at **Annex D**. Moreover, the product is anti-skid.⁴ The raw

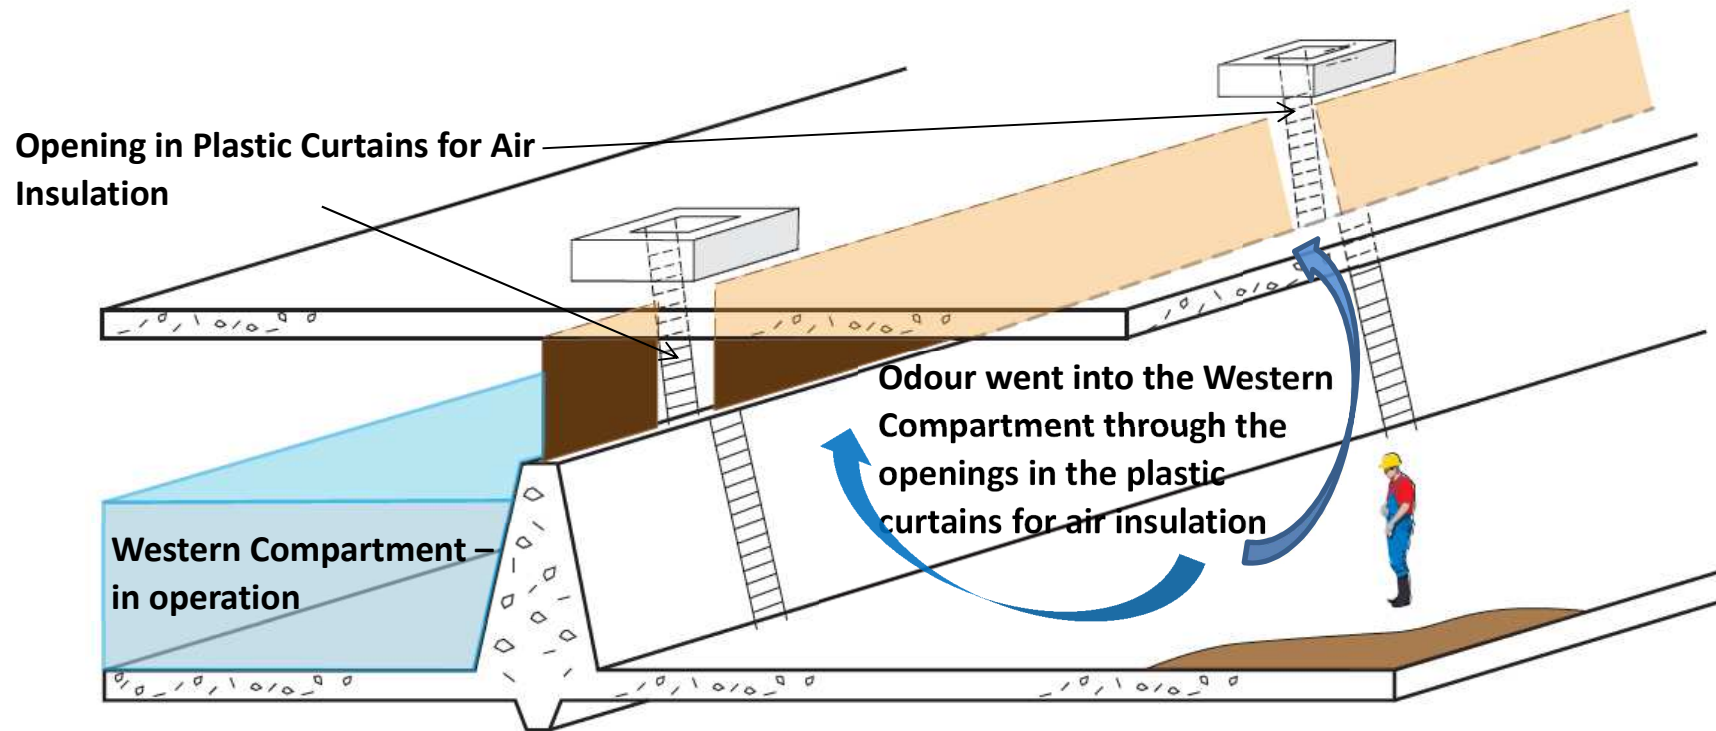
Figure 4 Odour went from eastern compartment to western compartment of the service reservoir

- 2.3.8 The investigation revealed that the contractor did not seal off the two openings without plastic curtains for air insulation at the locations of the access manholes / cat ladders. Instead, the contractor arranged to extract the air from inside of the service reservoir to the outside by means of blower fans, i.e. forced ventilation at the two access manholes.

- 2.3.9 The forced ventilation was however not effective. Since the air blowers were located at the access manholes on top of the division wall to extract air from the service reservoir, the VOC fumes from the corner of the eastern compartment flew in the direction to the western compartment. The VOC fumes in the eastern compartment were not totally extracted from the service reservoir and some of the VOC fumes got into the western compartment through the two openings and dissolved into the

drinking water. After the forced ventilation stopped at 5:30 pm on 18 November 2017, about 2 hours after the maintenance works had been finished on that day, the VOC fumes in the eastern compartment continued to diffuse into the western compartment through the two openings and dissolved in the drinking water in it. **Figure 4** illustrates how the VOC fumes from the eastern compartment got into the western compartment and dissolved in the drinking water.

- (ii) The use of materials with high VOC contents (including those in the raw materials) for maintenance works inside service reservoirs under condition (i) above should be stopped immediately;

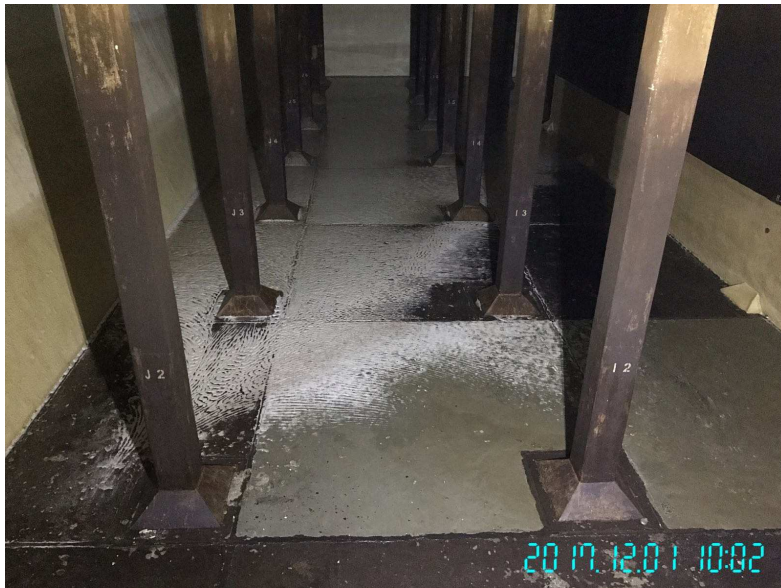
Location: Area near the access manhole close to the inlet of the western compartment

Observation: There is no sign of residual protective coating material found on the walls and floor slabs. The white sediments are residues of limes which are one of the ingredients in the water treatment process.

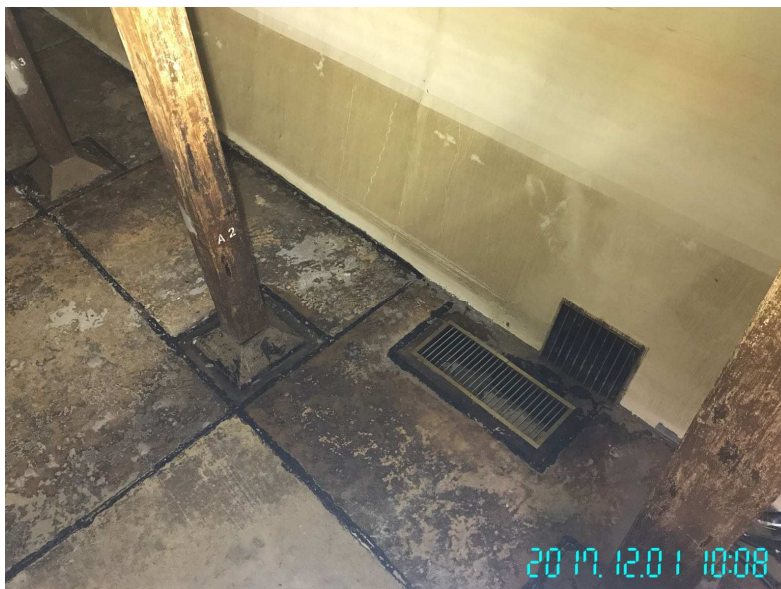
Location: Outlet of the western compartment

Observation: There is no sign of residual protective coating material found on walls and floor slabs.
