# 葵涌及荃灣食水出現異味事件 調查報告

2018 年 1 月

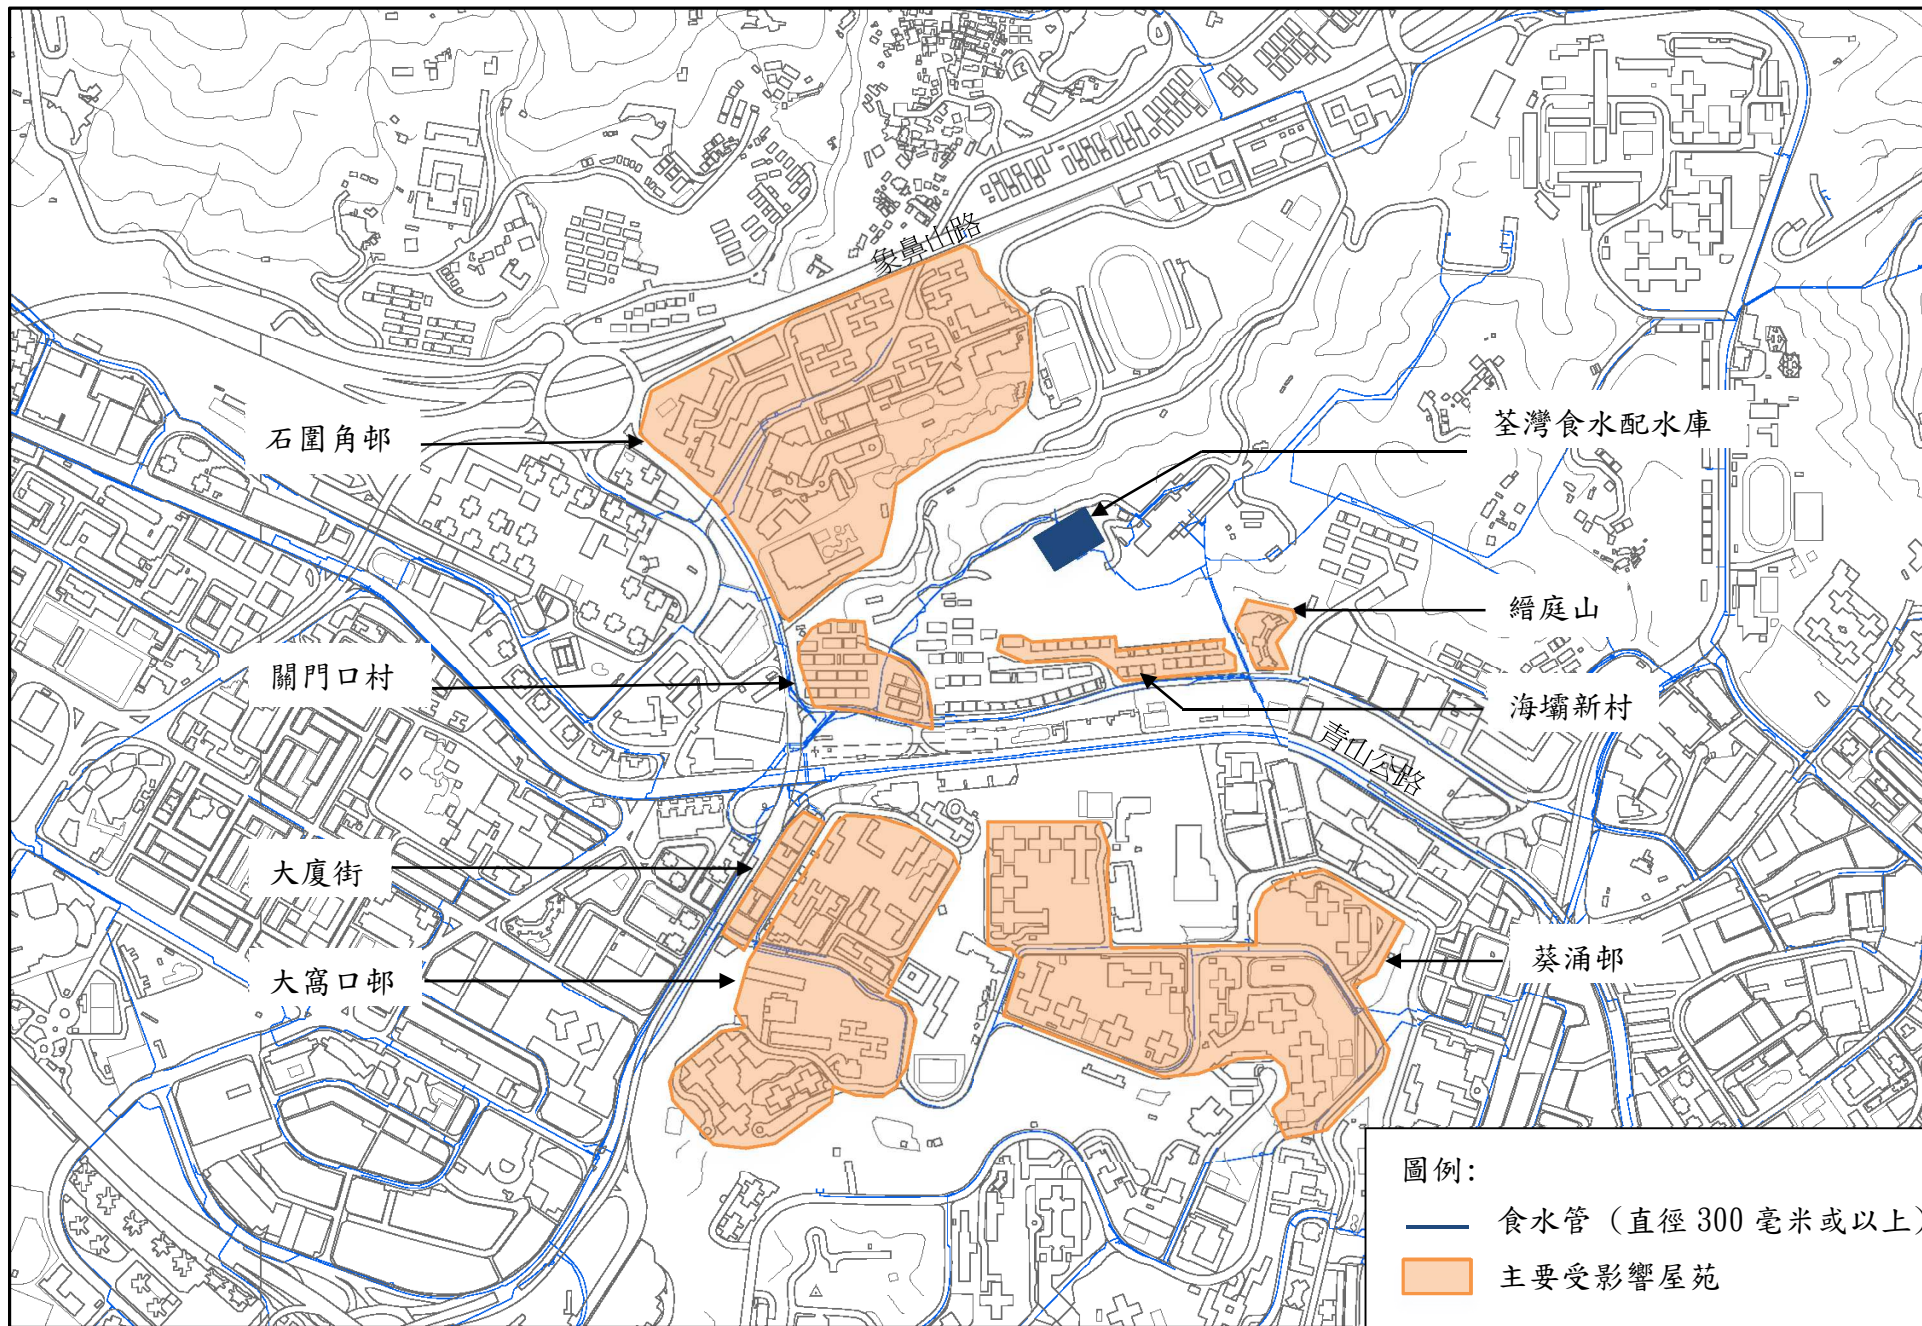
圖 1 - 接獲投訴食水出現異味的受影響屋苑/大廈

- 1.1 水務署於 2017 年 11 月 18 日(星期六)晚上至 2017 年 11 月 20 日(星期一)傍晚期間接獲葵涌及荃灣部分地區居民的投訴，表示食水出現異味<sup>1</sup>。
- 1.2 接獲投訴後，署方隨即派出待命隊伍人員跟進事件，並按既定程序於受影響地區的消防栓為供水網絡內的水管沖洗，以盡早恢復供應予用戶的食水水質。
- 1.3 當署方陸續接獲更多有關食水出現異味的投訴，遂估計問題可能與受影響地區的食水水源有關——荃灣食水配水庫。有見及此，水務署調動供水網絡，藉開啟/關上供水網絡的水閘，將受影響地區的水源由荃灣食水配水庫轉至荃灣二號食水配水庫、荃灣西低地食水配水庫以及荔枝角食水配水庫。調動受影響地區的供水水源在 2017 年 11 月 19 日晚上約 8 時完成。但是，水務署仍需繼續沖洗受影響地區供水網絡內的水管，以沖走來自原先荃灣食水配水庫的食水。直到 2017 年 11 月 20 日中午，供水網絡內的食水已再沒有檢測到異味。
- 1.4 然而，原先來自荃灣食水配水庫並已進入受影響屋苑/大廈內部供水系統的食水仍需排走，而它們的地下和天台的食水貯水缸亦需加以清洗。就此，水務署主動為受影響屋苑/大廈的管理處提供技術支援，協助他們排走來自原先荃灣食水配水庫的剩餘食水和清洗食水貯水缸。在排走該些剩餘食水後，署方在 2017 年 11 月 20 日傍晚起，已再沒有收到受影響地區居民關於食水出現異味的投訴。水務署亦從 2017 年 11 月 19 日晚起派出水車及/或水箱，為受影響居民提供食水，直至無此需要為止。
- 1.5 **圖 1** 展示接獲投訴食水出現異味的受影響屋苑/大廈。署方估計是次事件受影響的市民約有 60 000 人。

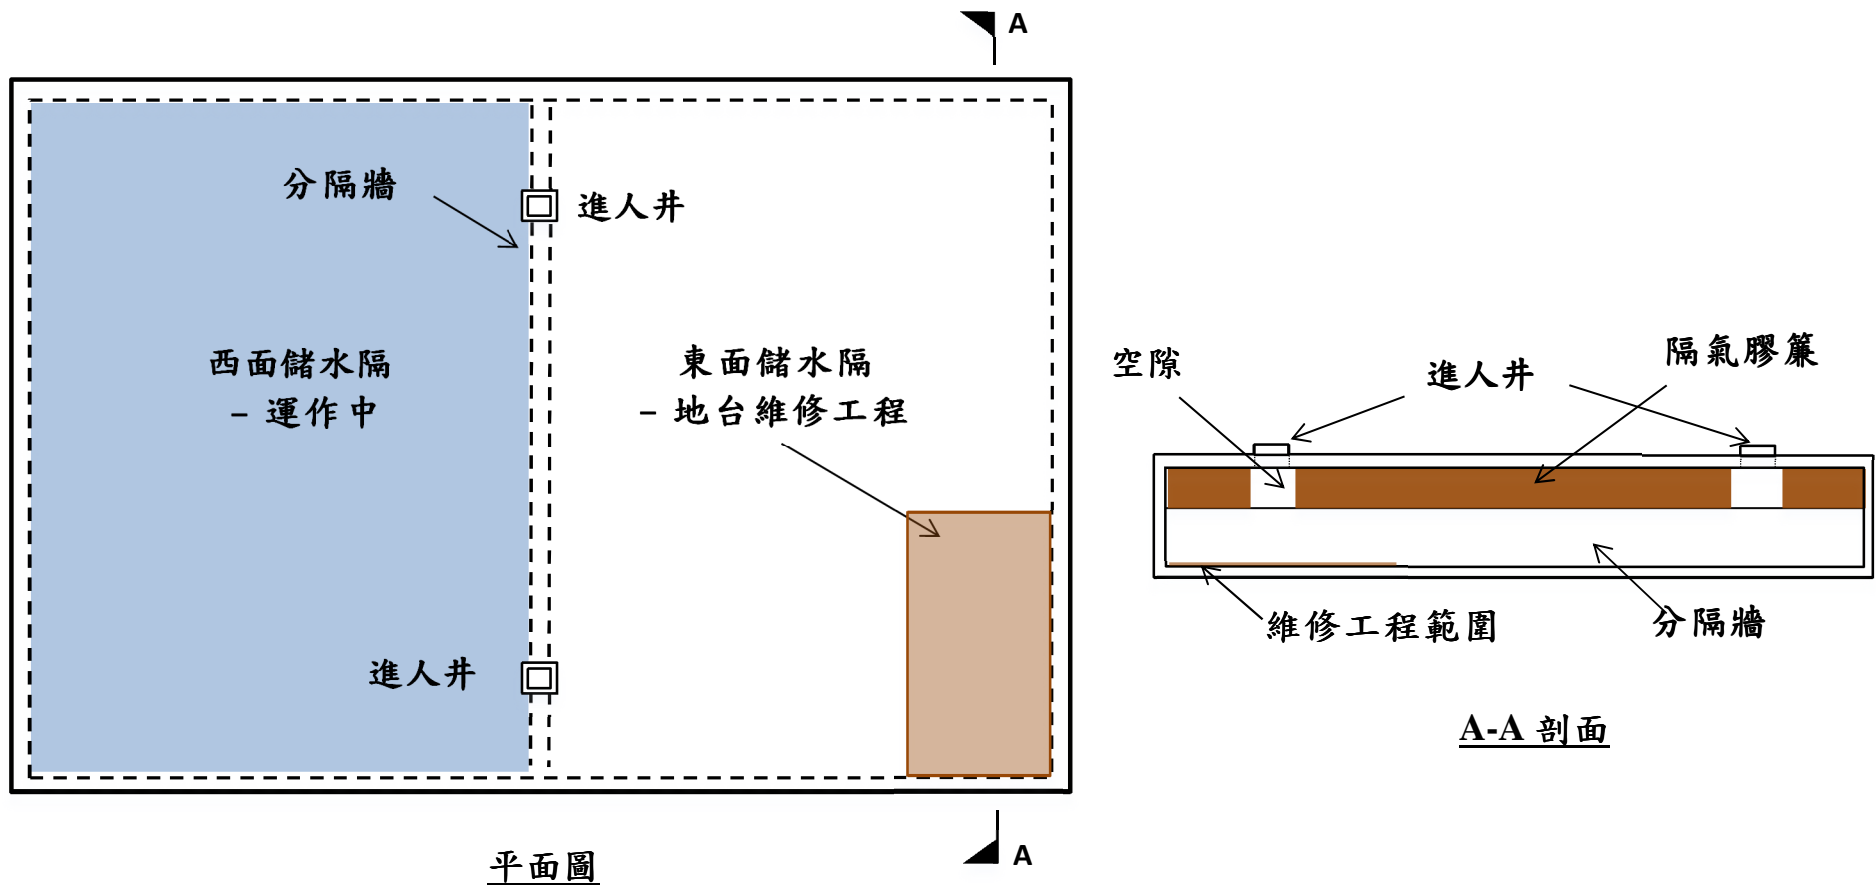
圖 2—荃灣食水配水庫的平面圖

2.3.1 荃灣食水配水庫於 1957 年建成，設有兩個儲水隔，由混凝土分隔牆隔開。這傳統設計可讓其中一個儲水隔進行維修工程時，另一儲水隔仍可繼續供水，以維持供水系統的可靠性。由於分隔牆頂部較配水庫上蓋低約 2.5 米，因此分隔牆頂部與配水庫上蓋之間存有空隙，由隔氣膠簾封閉。

2.3.2 然而，使用了 60 年的荃灣食水配水庫屬舊式設計，在分隔牆上方設有兩個進人井及爬梯，方便工作人員在進行維修工程時進出配水庫。因此，隔氣膠簾未能完全封閉位於分隔牆頂部的進人井及爬梯位置的空隙。

- (i) 在配水庫其中一個儲水隔進行維修工程而另一儲水隔維持運作供水的情況下，配水庫上蓋與分隔牆頂的空隙須完全封閉；
- (ii) 在(i)所述情況下於配水庫進行的維修工程，應即時停用含高 VOC 成分的物料(包括原材料)；
- (iii) 在進行有可能影響食水水質的建造或維修保養工程前，須要求承建商聘用專業人員進行水質影響評估(Water Quality Impact Assessment)，其中包括評估工程影響食水水質的風險、確定所需的監督程度、制訂相應的預防措施，以及訂立包括定期視察和水樣本測試在內的監察制度。有關評估須由水務署高級專業人員審核及批准；
- (iv) 加強前線工程人員的定期培訓，提高他們對建造及維修工程可能對食水水質構成風險的警覺性；

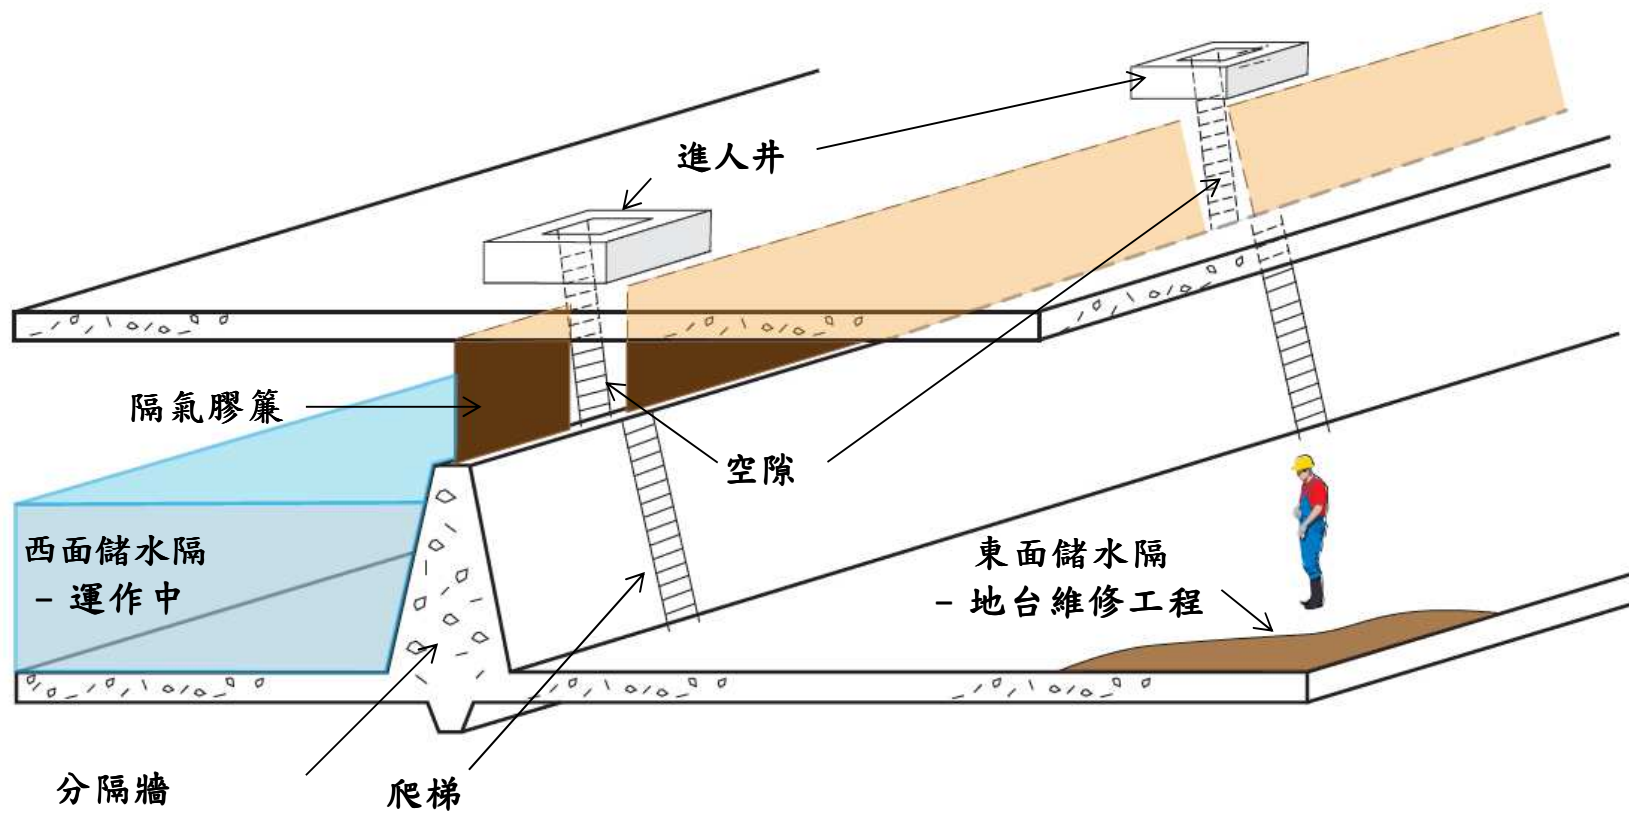
圖 3—東面儲水隔地台維修工程的示意圖

2.3.4 荃灣食水配水庫的東面儲水隔自 2017 年 10 月初開始進行維修保養工程，以維持其耐用性和防水效能。該儲水隔在 2017 年 10 月 2 日排乾，而西面儲水隔仍繼續運作供水。於 2017 年 10 月 7 日開始的東面儲水隔維修工程首先修補磨損的牆壁和地面裂縫，為其塗上環氧樹脂塗層 (MasterProtect 180) 和填縫料 (Polyseal PS)。在這期間，水務署並沒有接到食水出現異味的投訴。在維修保養工程的最後階段，承建商於東面儲水隔地台的磨損部分 (約 250 平方米，即地台面積的 16%) 塗上保護塗層。圖 3 展示了東面儲水隔地台維修工程的示意圖。

2.3.5 用作修補東面儲水隔地台磨損部分的保護塗層是 SPUA-406，屬聚脲 (Polyurea) 物料，是英國水務法規諮詢計劃 (UK Water Regulations Advisory Scheme - WRAS) 認可的產品。凝固後的保護塗層不含對人體有害的物質，符合英國標準 BS6920，適用於食水設施工程。有關核准文件的複印本載於附件 D。此外，該產品有防滑功能<sup>4</sup>。SPUA-406 的原材料含有 VOC，在保護塗層凝固期間會揮發並釋出異味。當保護塗層完全凝固後，VOC 會完全揮發及不會再釋出氣味。

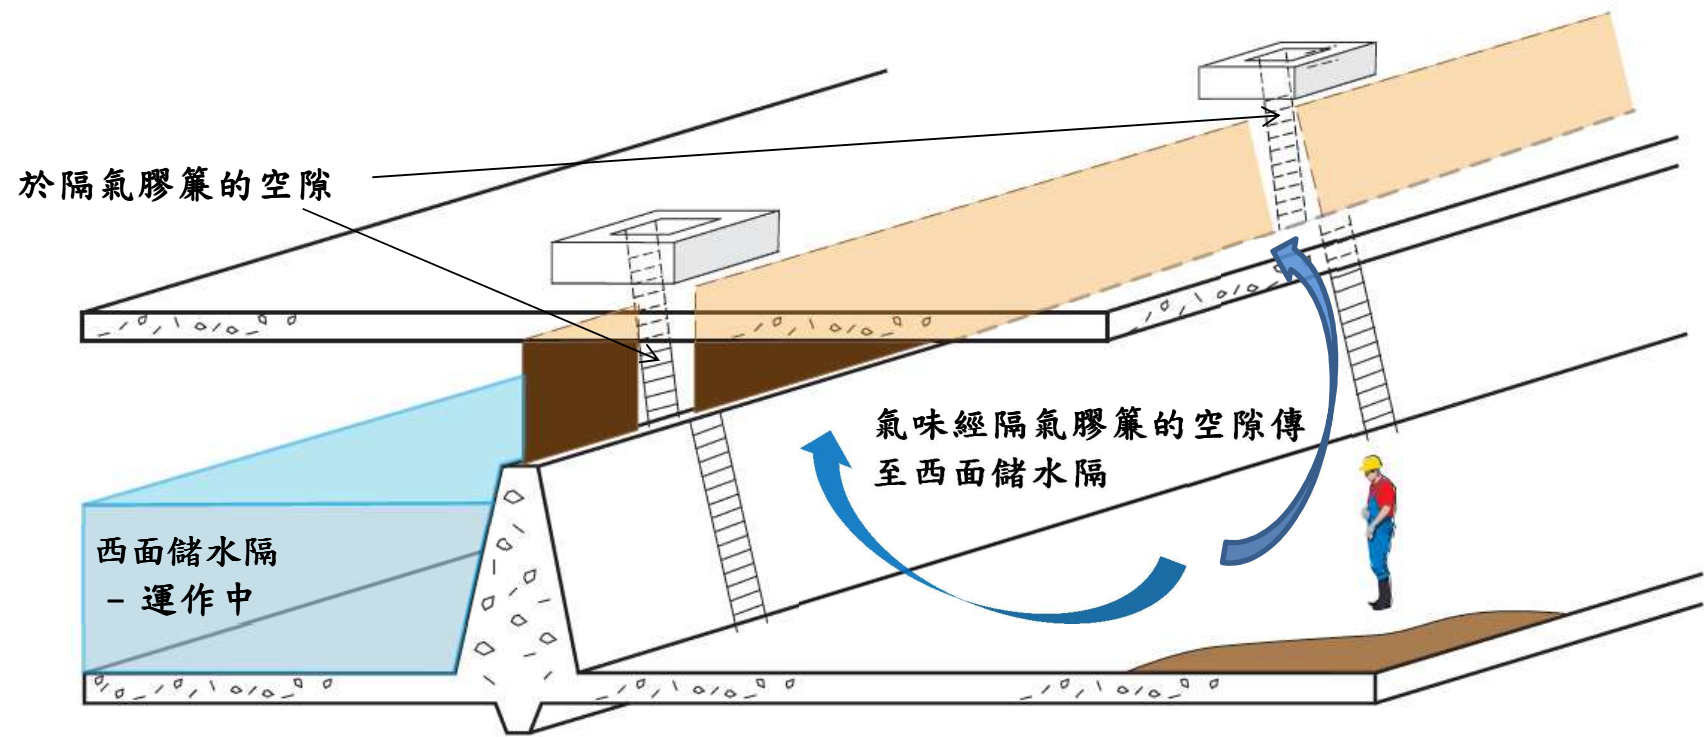
圖 4—氣味由配水庫東面儲水隔傳至西面儲水隔

- 2.3.8 調查發現承建商沒有在進人井及爬梯位置(沒有設有隔氣膠簾)把兩個空隙封妥，卻於兩個進人井安裝吹風機進行壓力抽風，將空氣由配水庫內部排至外面。
- 2.3.9 然而，壓力抽風未能發揮效用。由於吹風機是安裝在分隔牆上方的進人井位置，將空氣抽到配水庫外，因此東面儲水隔角落的 VOC 氣體順勢流向西面儲水隔。東面儲水隔的 VOC 氣體未能全部排出配水庫外，部分 VOC 氣體經由上述兩個空隙傳至西面儲水隔，並溶於食水。在 2017 年 11 月 18 日，維修保養工程竣工停工約兩小時後，壓力抽風系統於當日下午 5 時半停止運作，東面儲水隔的 VOC 氣體繼續經由該兩個空隙傳至西面儲水隔，並溶於其貯存的食水。圖 4 說明了 VOC 氣體如何由東面儲水隔傳至西面儲水隔，並溶於食水。
- 2.3.10 含有 VOC 的食水由荃灣食水配水庫西面儲水隔經水管輸送到用戶。因此，當用戶在水龍頭取水時，VOC 從食水中釋出，給用戶帶來異味問題。由於 VOC 的「嗅點」很低，即使食水中含有極少量的 VOC，仍可被用戶察覺。為證實這點，調查小組成立了氣味測試小組以確認水中二甲苯<sup>5</sup> (保護塗層原料中 VOC 的主要成分)的「嗅點」。結果顯示，所有小組成員在二甲苯濃度遠低於其世衛準則值的情況下均能察覺到氣味。有關氣味測試小組的結果詳情，請參閱附件 E。

- (i) 今次葵涌及荃灣部分地區的食水出現異味，是由於在荃灣食水配水庫東面儲水隔地台塗上的保護塗層釋放出 VOC。VOC 氣體經分隔牆上兩個空隙(在沒有被隔氣膠簾封閉的進人井及爬梯位置)傳至正在運作中的西面儲水隔，並溶於其貯存的食水，然後輸送到用戶。
- (ii) 事件期間供應至用戶的食水雖然帶有異味，但並不會對健康構成危險。由於 VOC 的「嗅點」很低，即使其濃度符合世衛準則，食水中含有極少量的 VOC 仍可被用戶察覺。

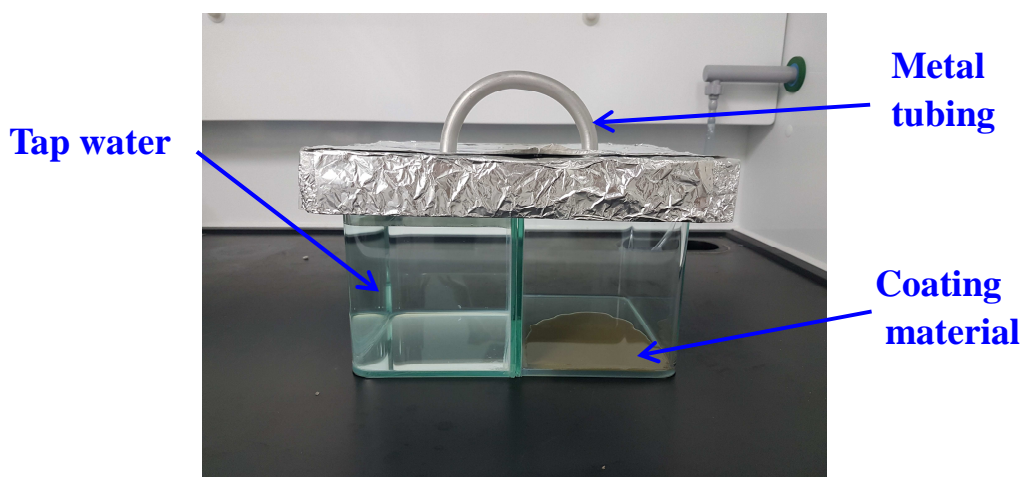
Figure F1

1.2 In the benchtop study, a pair of glass tanks were used to simulate the two compartments. The tanks were covered and holes of about 0.5 cm in diameter were drilled on the cover at the four corners of both tanks to simulate the air vents. One tank was filled with tap water while a layer of protective coating material was spread on the bottom of the other as thinly as possible (Figure F1). While the tanks were covered, they were interconnected by a metal tubing simulating the openings in the plastic curtains. Details of the set-up of the glass tanks and the SR compartments are indicated in Table F1.

2.3 The experimental results showed that a detectable level of xylene in water was caused by diffusion of VOCs from one glass tank to the other through the narrow metal tubing. It thus demonstrated that application of protective coating material in an SR compartment could lead to odour in the drinking water in the adjacent compartment due to diffusion of VOCs.

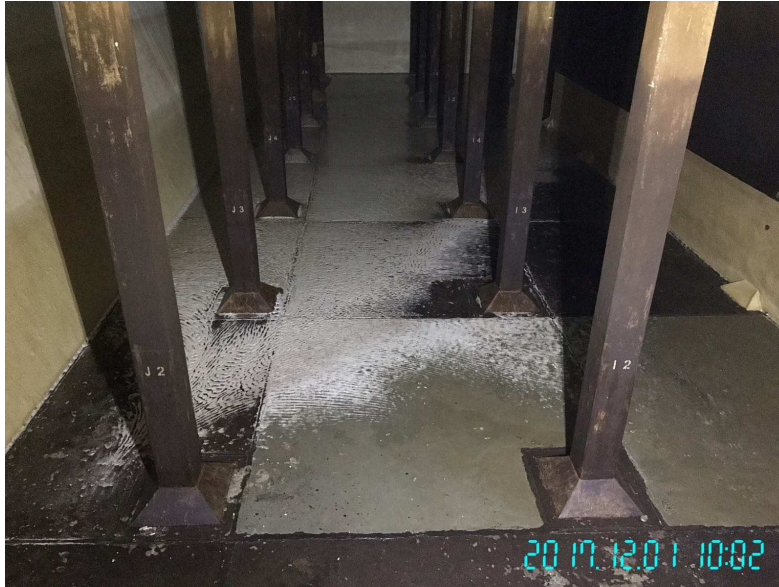
**Location:** Area near the access manhole close to the inlet of the western compartment

2.4.3 因此，調查小組認為今次事件的成因並非由於有保護塗層原料被意外倒入西面儲水隔所引致。

**Observation:** There is no sign of residual protective coating material found on the walls and floor slabs. The white sediments are residues of limes which are one of the ingredients in the water treatment process.

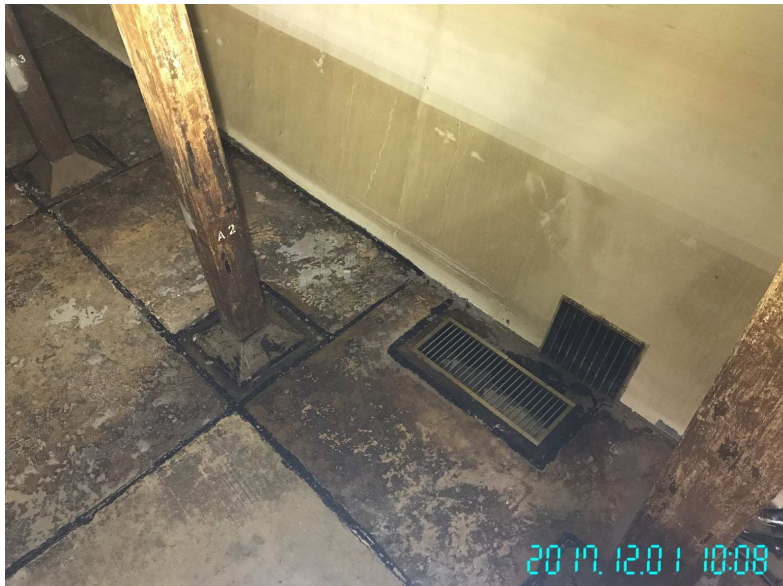
**Location:** Outlet of the western compartment

**Observation:** There is no sign of residual protective coating material found on walls and floor slabs.
