優質服務 RESOURCEFUL OUTPUT

- 更換計劃 Replacement Plans
- 地面資產 Surface Assets
- 保管資產 Care of Assets
- 品質保證 Quality Assurance
- 效率助益 Efficiency Benefits
- 滲漏控制 Leakage Control
- 地理資訊系統技術 GIS Technology

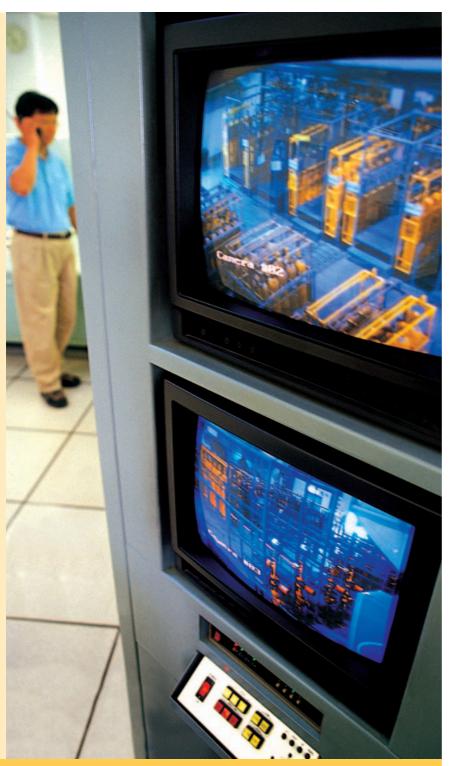
閉路電視是監察設備運作的有用工具。
 CCTV is a useful tool for monitoring plant operation.

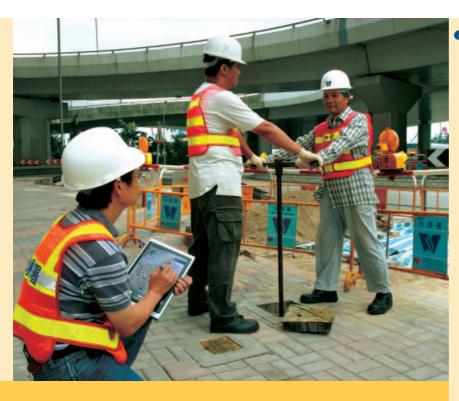
◆外勤員工可透過使用地理資訊系統技術 更有效地運作水閥。 With the use of GIS technology, site staff are able to perform valve operation more efficiently.

Geographical Information System (GIS) Technology is applied in the development of the Digital Mapping System, which captures in digital format the complete supply and distribution networks with over 7 000 km of fresh and salt water mains.

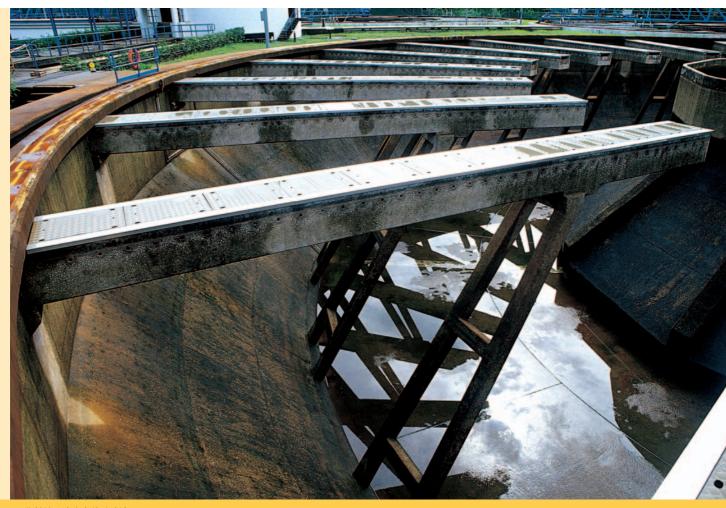
▲ 位於沙田濾水廠的澄清池。 Clarifier at Sha Tin Water Treatment Works.

Trials carried out at the Sha Tin Water Treatment Works showed that the inclined tube technology was costeffective as well as viable in increasing the throughput of a clarifier. The same technology will be applied to other clarifiers at the Sha Tin Water Treatment Works and the Tuen Mun works.
