Common Rectification Works for Enhancing Water Safety

Common Rectification Works

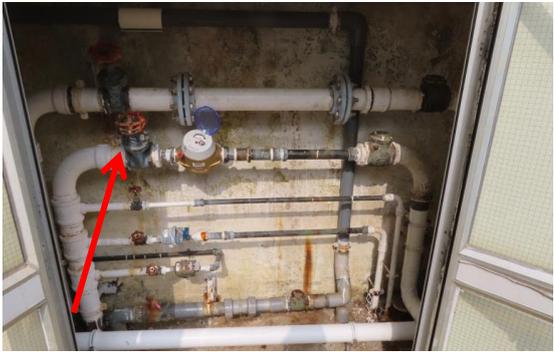
Relevant Part of the Plumbing System	Item	Reference Photo
Water pipework	Add labels or markings for identification of potable and non-potable water pipes

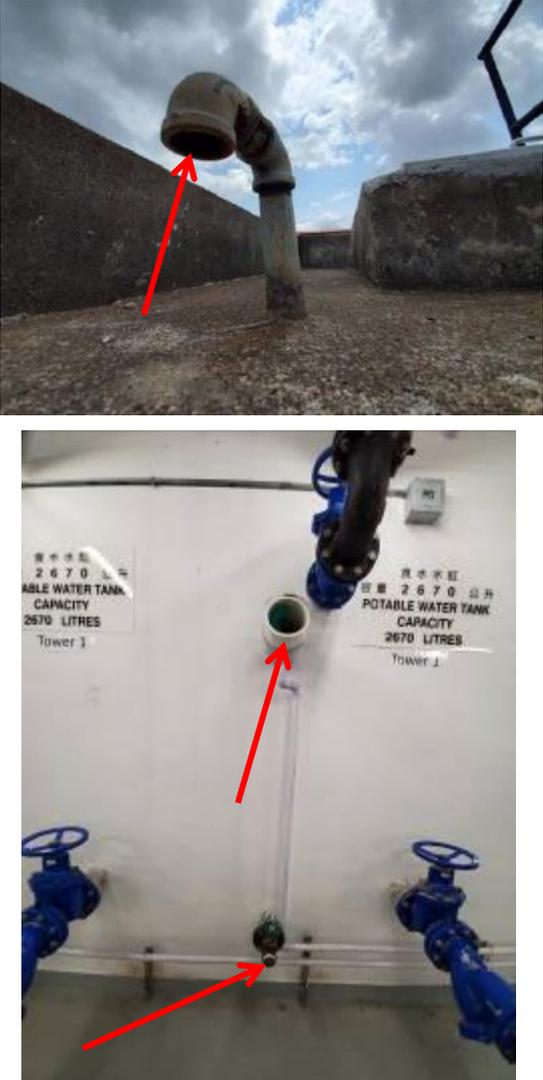
Relevant Part of the Plumbing System	Item	Reference Photo
Water storage tanks	Add fine, gnaw-proof insect-proof mesh at tank vents, overflow pipes and warning pipes

<p>The first photo shows an outdoor concrete water tank with a curved vent pipe. A red arrow points to the open end of the pipe where a mesh cover is being installed. The second photo shows an indoor view of a white water tank with two blue valves. A red arrow points to a vent pipe opening on the tank's surface, and another red arrow points to a lower pipe connection, both indicating where mesh should be added. Labels on the tank indicate a capacity of 2670 litres.</p>
Water storage tanks	Replace the water tank cover with a suitable close fittings lockable double sealed cover

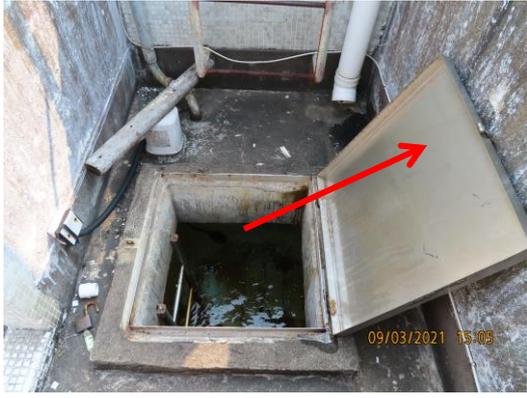
<p>The photo shows an open access point to a water tank. A red arrow points to the existing cover, which is being replaced. A date stamp '09/03/2021 15:05' is visible in the bottom right corner of the photo.</p>

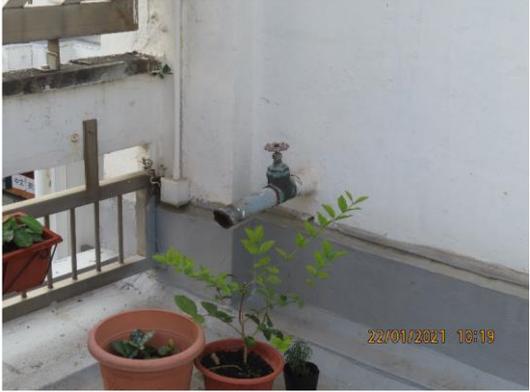
Relevant Part of the Plumbing System	Item	Reference Photo
Water storage tanks	Properly plug the drain-off pipe to prevent unauthorized operation of the control valve at drain-off pipe

<p>A photograph of a utility room showing a drain-off pipe with a control valve. The pipe is connected to a wall and has a valve handle. There are potted plants in the foreground.</p>
Water storage tanks	Replace with floats made of copper alloy or stainless steel

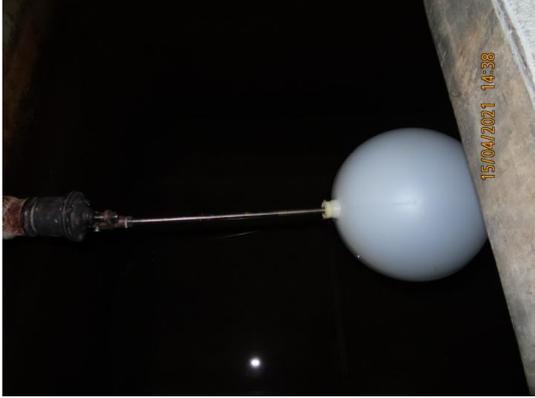
<p>A close-up photograph of a float valve mechanism. A white spherical float is connected to a metal rod and a valve handle.</p>
Non-return devices	Replace the defective non-return device

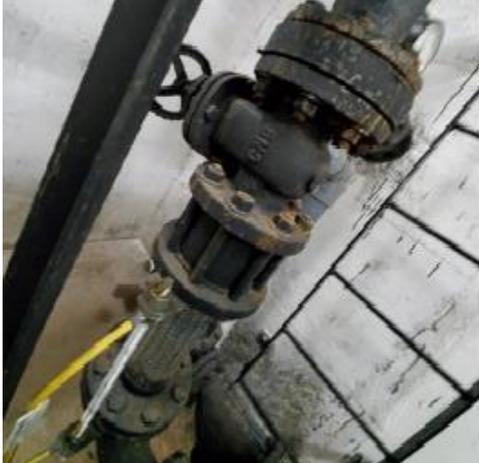
<p>A photograph of a defective non-return device (check valve) installed on a pipe. The device is heavily corroded and appears to be leaking.</p>
Non-return devices	Replace the stopcock before the water meter with loose jumper stopcock

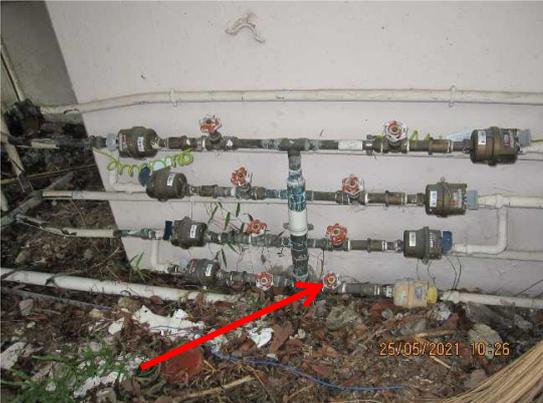
<p>A photograph of a loose jumper stopcock installed on a pipe. A red arrow points to the stopcock. The area is cluttered with debris.</p>

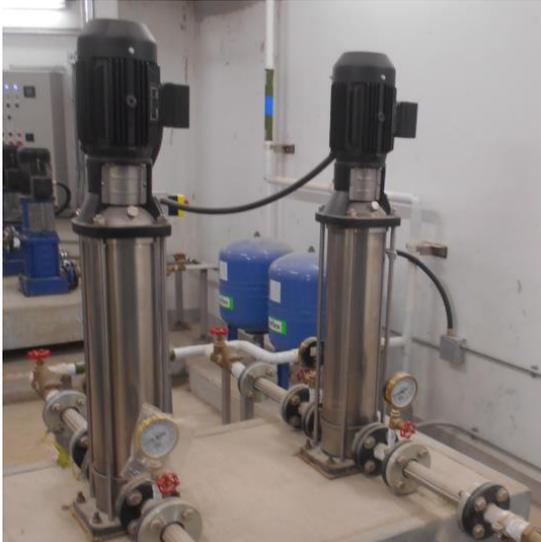
Relevant Part of the Plumbing System	Item	Reference Photo
Pump and booster pump	Replace the defective pump and booster pump

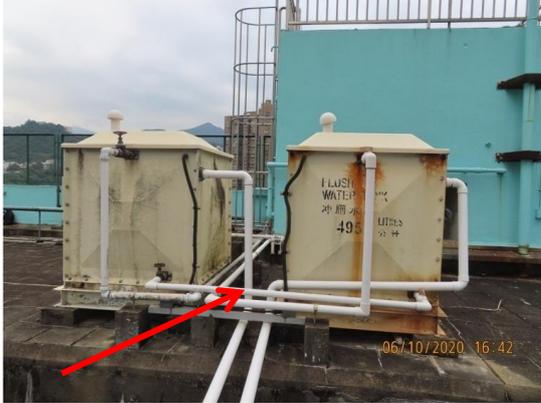
Cross-connection between potable and non-potable water supplies	Rectify the cross-connection
