# 大潭篤原水抽水站

## Tai Tam Tuk Raw Water Pumping Station

## 背景 Background

## 修復 Restoration

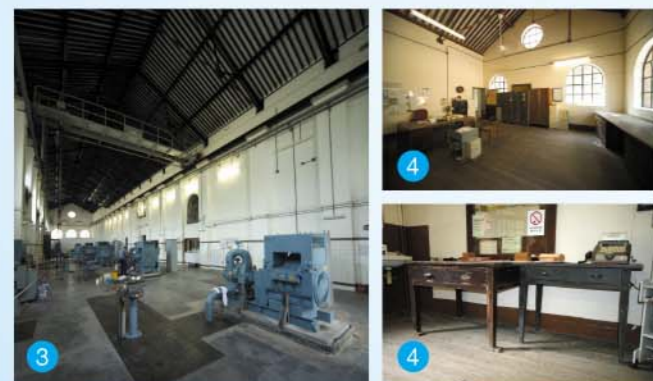
抽水站為磚砌建築②，頂部最高離地約12米，分別有安放水泵的大堂③、鍋爐房、寫字間④及煤炭儲存間等。建築物頂部為瓦片木樑，由鐵鑄金字式構架承托，百多年來未作任何重大改動。抽水站一直沿用至今，成為水務署運作中最古舊的一個抽水站。

The pumping station is a red brick structure ②. The pitched roof is about 12 metres above ground. It has a pump hall ③, a boiler room, an office ④ and coal storage space. The pitched roof comprises Chinese-styled tiles supported on timber purlins which in turn rest on metal trusses made of cast iron frames and steel tie rods.

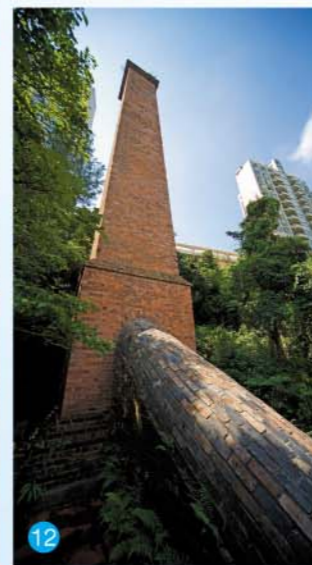
接續的重點保護工作是修復抽水站的煙囪⑨。該磚砌煙囪始建於1904年，座落於抽水站以西的山腰上，為當時燃煤炭排煙之用。底部為一正方形基座，旁邊有拱形通風口，正中位置與抽水站窩爐排煙管連接。煙囪高19米，方形橫切面向上收窄至頂部約邊長1.7米正方形。西面外牆上安裝有生鐵鑄成的腳踏，可供攀爬至煙囪頂部。1950年代水泵改為用柴油發動後，煙囪因此荒廢並破損嚴重，除部分磚面受到嚴重侵蝕⑩外，煙囪頂端更為植物根部入侵而爆裂。

The restoration works then proceeded to the chimney ⑨ of the pumping station. The chimney was constructed in 1904 and was located in the middle of a slope west of the pumping station. It was used for the emission of smoke arising from the coal-fire operation. The base of the chimney was a square with a side opening and a smoke shaft connected with the boiler room of the pumping station. The chimney was about 19 metres high with a square cross-section reduced to about 1.7 metres at the top. The west face of the chimney was installed with cast-iron steps for access to the top. The chimney had not been in use since the 1950s and was much dilapidated ⑩.
