常見控制水安全風險的改善工程

常見改善工程項目

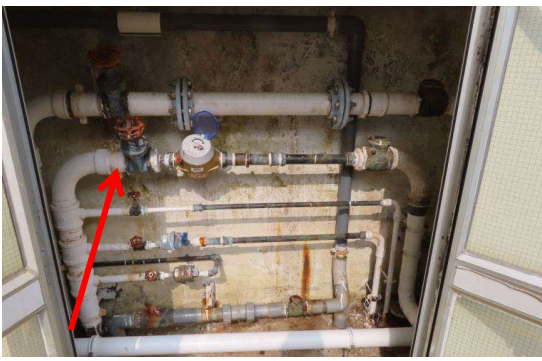
相關供水系統部件	項目	參考照片
食水水管	加上標記，分辨食水和非食水設施喉管

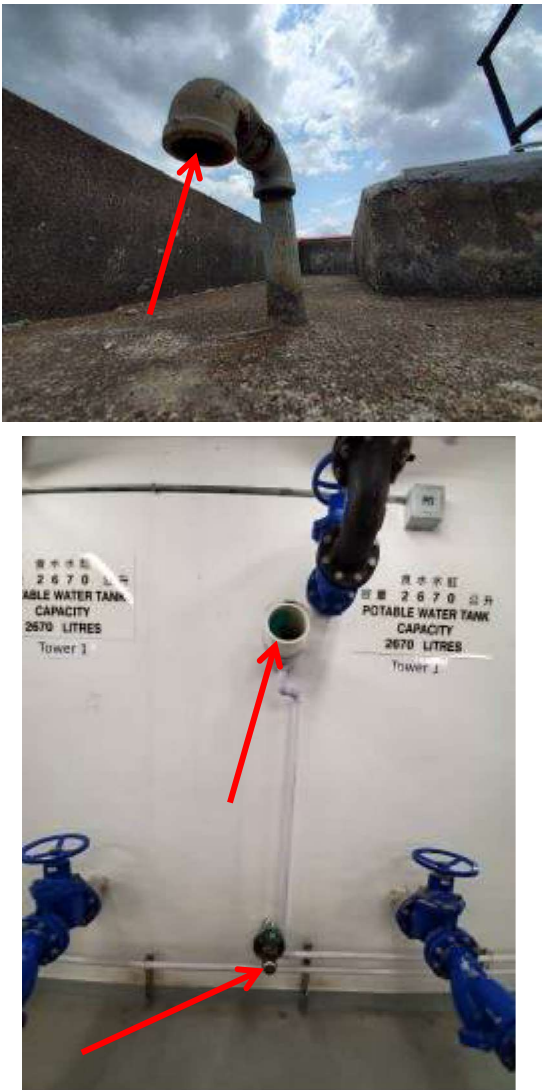
食水水箱	於水箱通風口、溢流管及警戒管新造細密、不易咬破的防護網

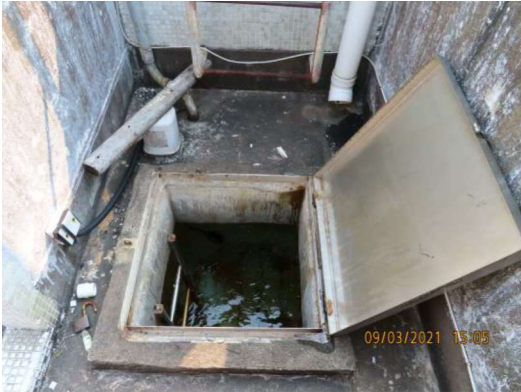
相關供水系統部件	項目	參考照片
食水水箱	裝置合適可上鎖的緊合複式封蓋水缸蓋

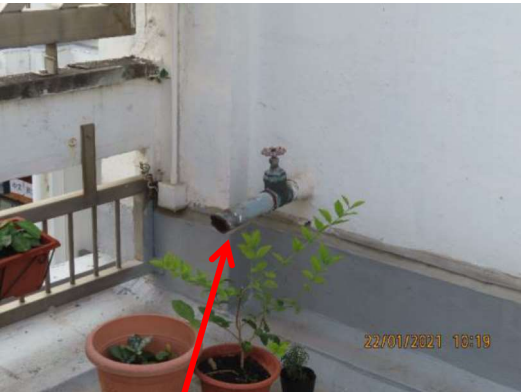
食水水箱	應適當地予以填塞排水管，以免控制閥遭人擅自操作

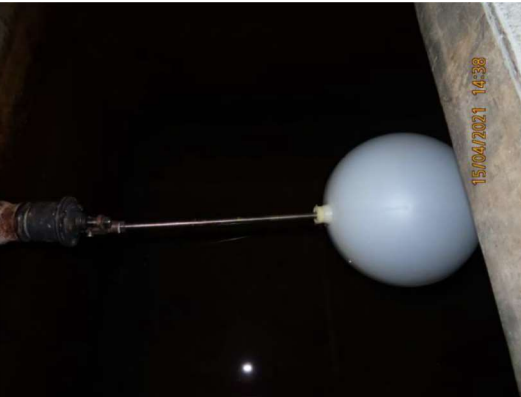
食水水箱	更換食水貯水缸的浮體為銅合金或不銹鋼製造

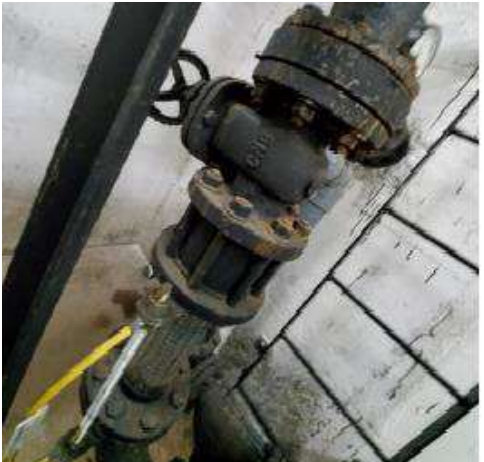
防回流裝置	更換已損壞的防回流裝置
