**Report of the Task Force on
Investigation of Excessive
Lead Content in Drinking Water**

October 2015

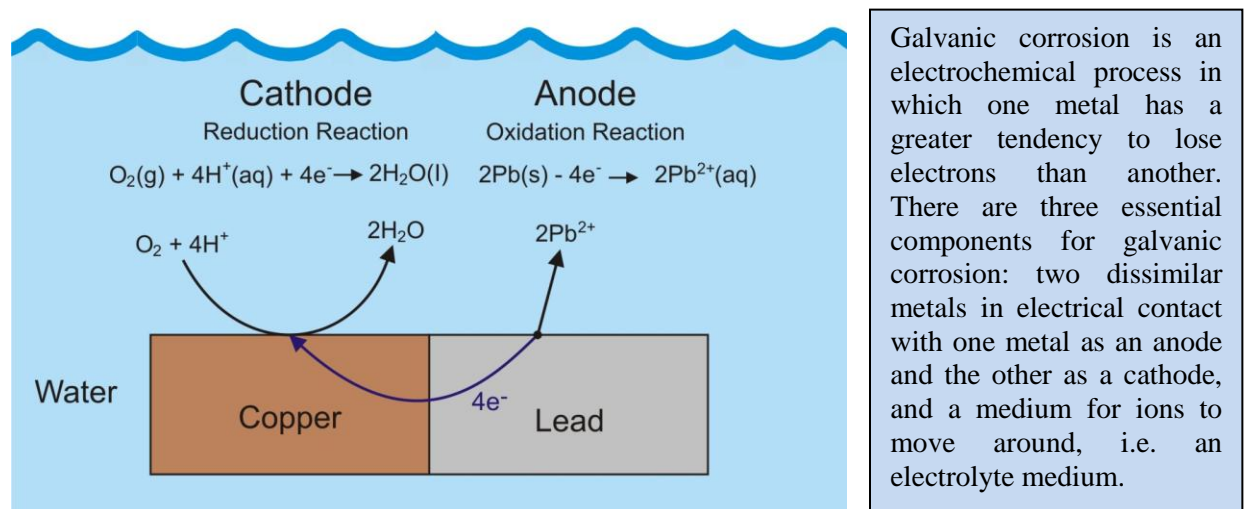
Figure 2.7 Schematic diagram illustrating lead leaching by galvanic corrosion

2.8.1 The mechanism for lead leaching from copper alloy fittings and leaded solder joints in contact with water is the formation of a corrosion cell between the lead and the copper resulting in galvanic corrosion. Under this setting, copper acts as the cathode metal, lead acts as the anode metal and water is the electrolyte medium. As lead has a greater tendency to lose electrons to form positive ions than does copper, lead ions leach into water as a result of galvanic corrosion and the process is shown in **Figure 2.7**.
