**Investigation Report on
the Incident of Unpleasant Odour
in Drinking Water
in Kwai Chung and Tsuen Wan**

January 2018

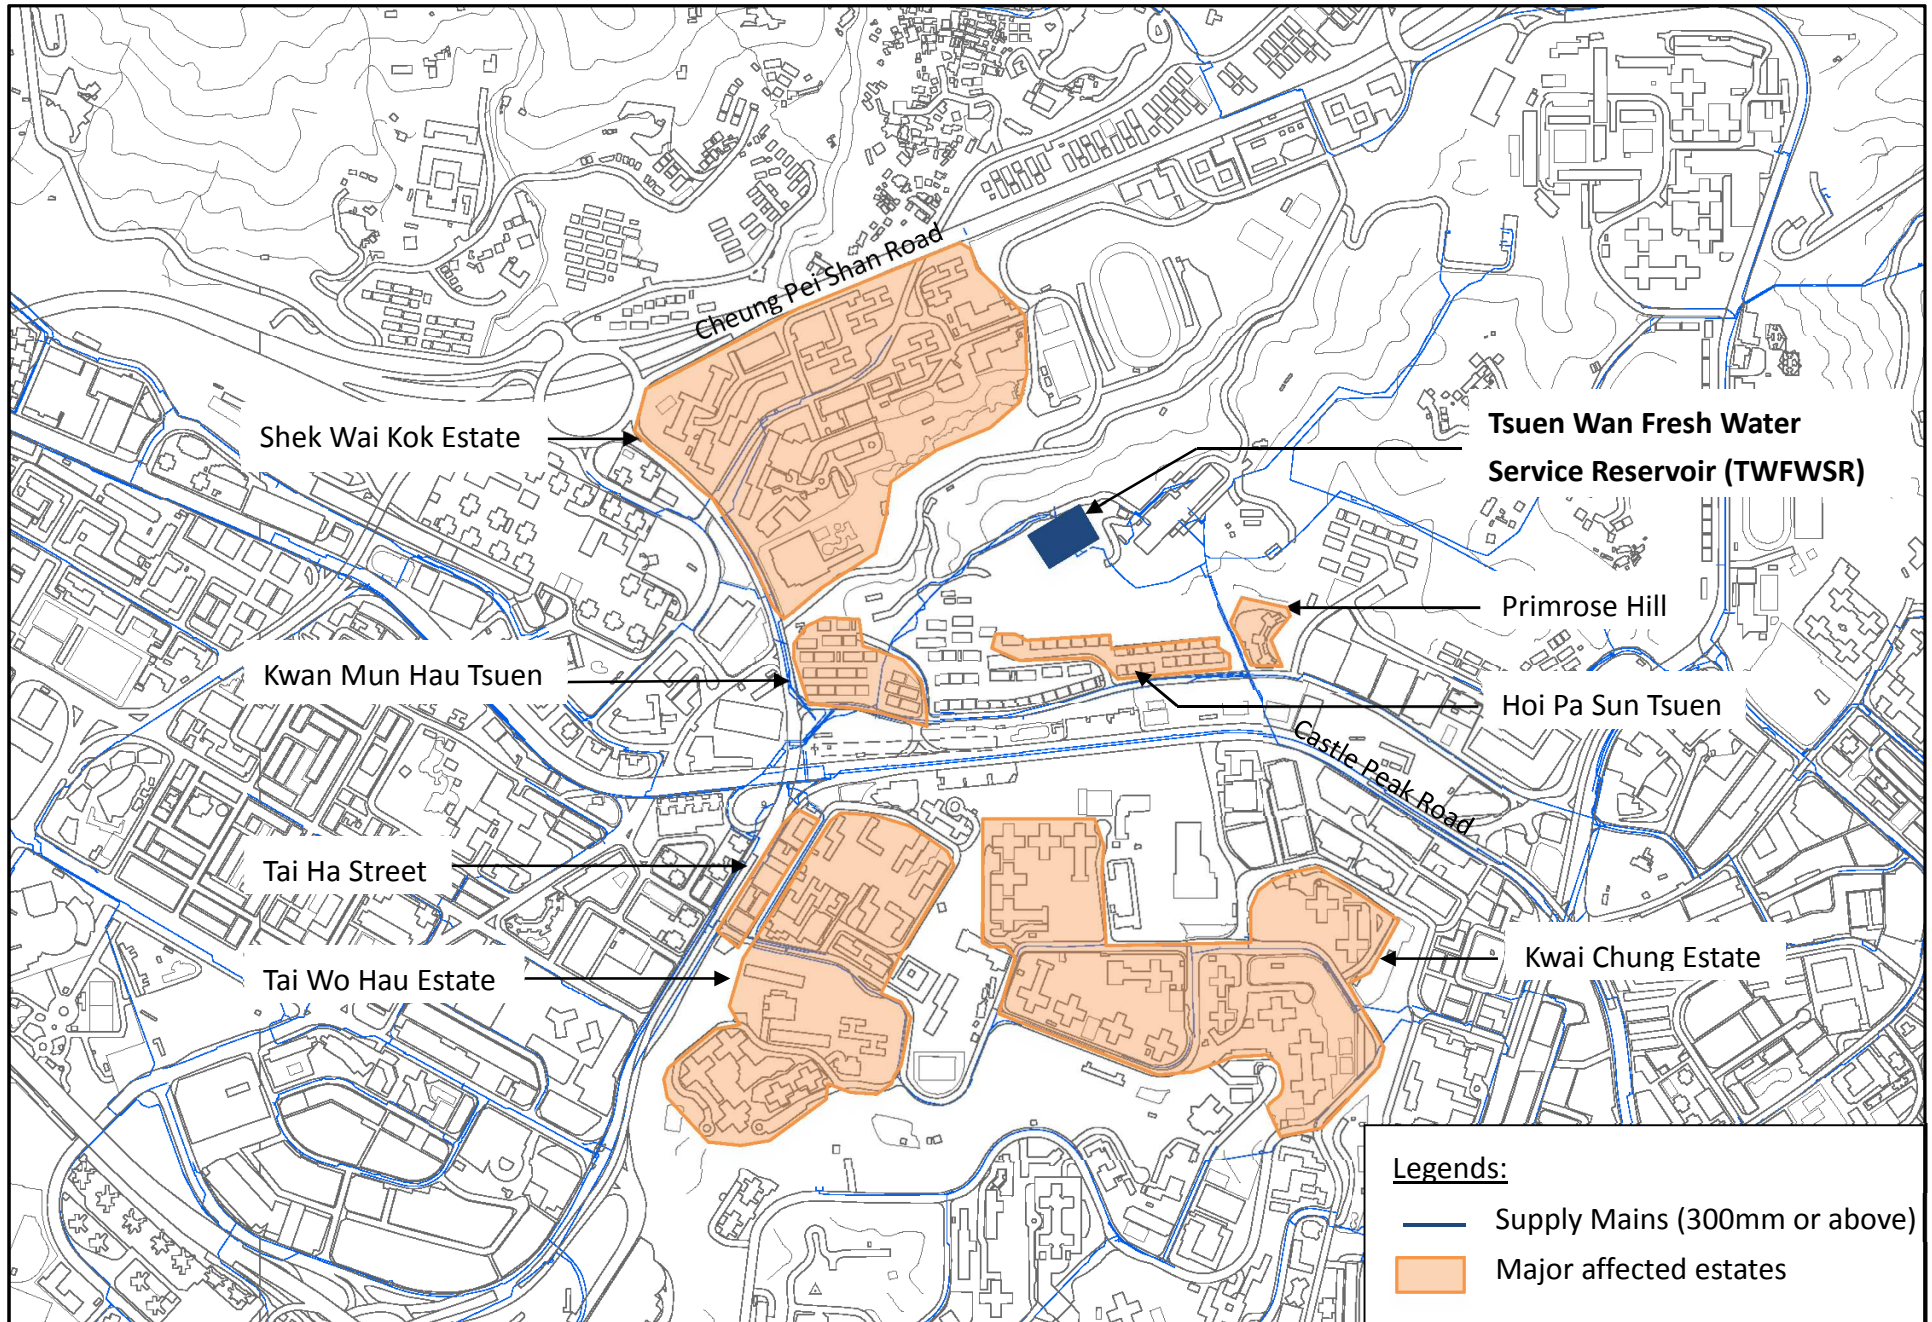
- 1.5 **Figure 1** shows the affected housing estates / buildings from which complaints on unpleasant odour in drinking water were received. The WSD estimated that there were about 60 000 residents affected by the incident.

Figure 1 - Affected housing estates / buildings from which complaints on unpleasant odour in drinking water were received.
