資產管理

ASSET MANAGEMENT

水是生命之源
Water's
Life

- 資產管理計劃
Asset Management Plans
- 資產更換計劃
Asset Replacement Programmes
- 資產保養
Asset Maintenance
- 水管爆裂
Mains Bursts
- 滲漏控制
Leakage Control
- 風險及危機管理
Risk and Crisis Management

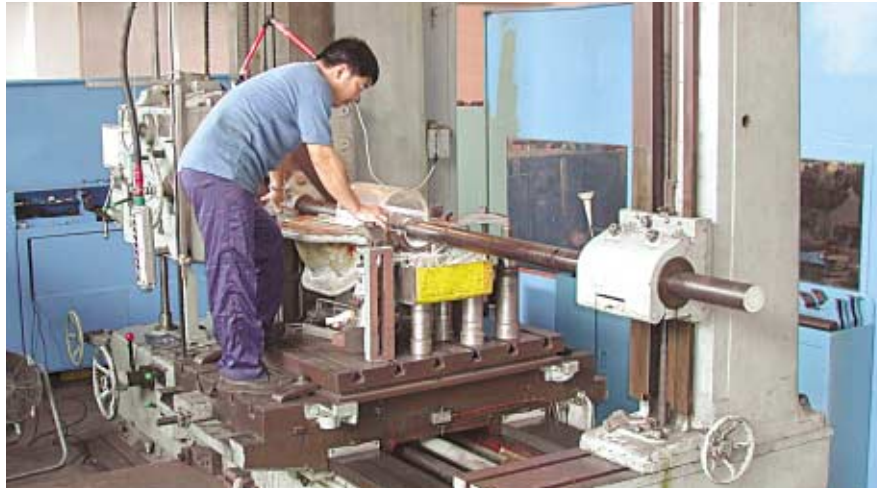
在機械工場內打磨水泵泵殼。
A pump casing being machined in Mechanical Workshop.

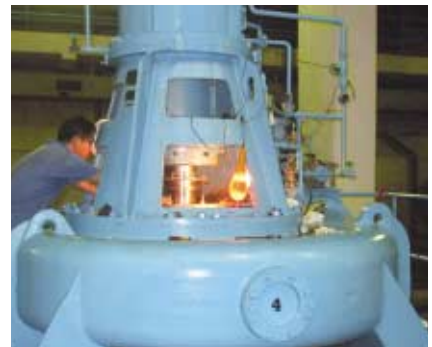
現場檢查和維修大型水泵。
A large water pump being inspected and repaired on site.

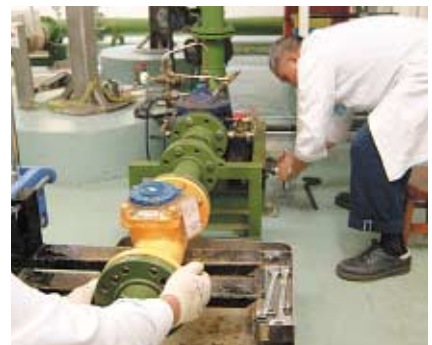
測試大型水錶的準確程度。
Conducting accuracy test on a large water meter.

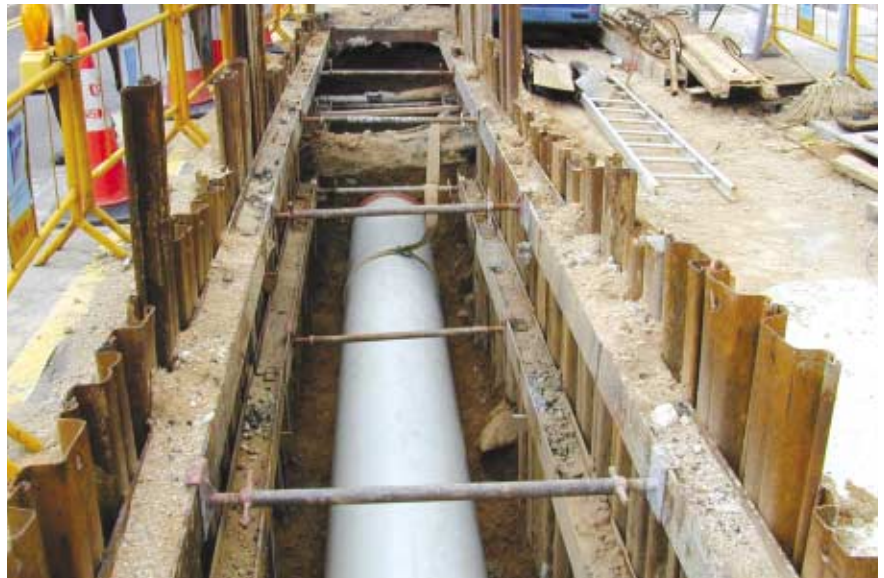
安裝地下水管工程進行中。
An underground water main being laid.

commenced in 2000 to replace or rehabilitate some 3 000 kilometres of water mains at an estimated cost of \$10 billion. Stage One of the project, covering 350 kilometres of water mains, is scheduled for completion in 2008.

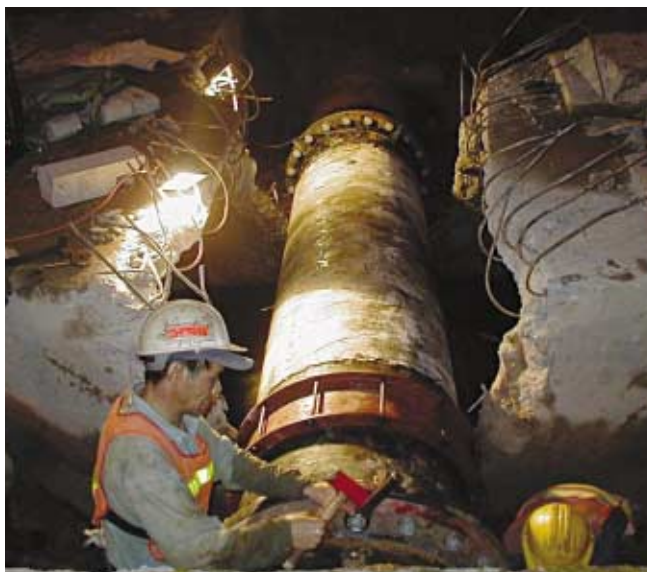
員工正搶修一條爆裂水管。
A burst water main being repaired.

The past two years have seen a steady decrease in the number of mains bursts as a result of our active water mains replacement and rehabilitation programme, enhanced preventive maintenance works and trench inspections. There has also been a continued improvement in the time for isolating burst mains and the time for restoring supply interruptions due to streamlining of handling procedures of mains bursts.

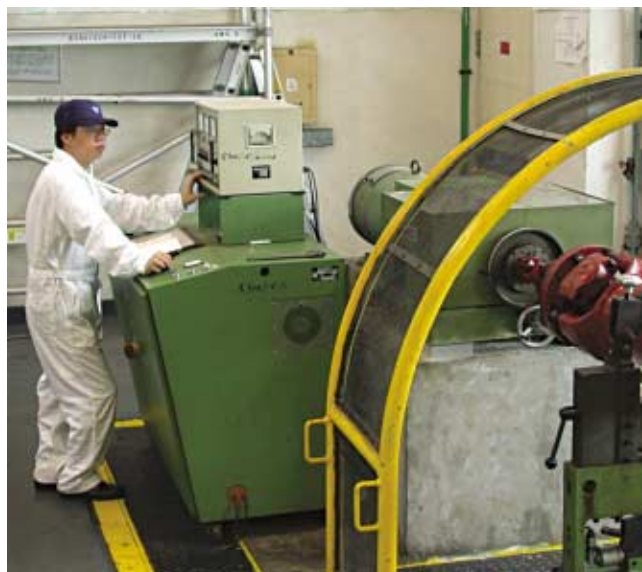
工作人員正為一個剛完成維修的電動機轉子作轉動平衡測試。
A repaired electric motor rotor being tested on a dynamic balancing machine.

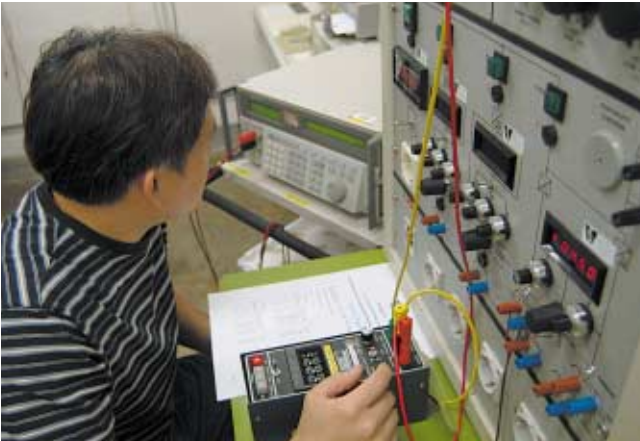
技術人員正為電子儀器進行校正工作。
Staff conducting calibration of electronic instrument.

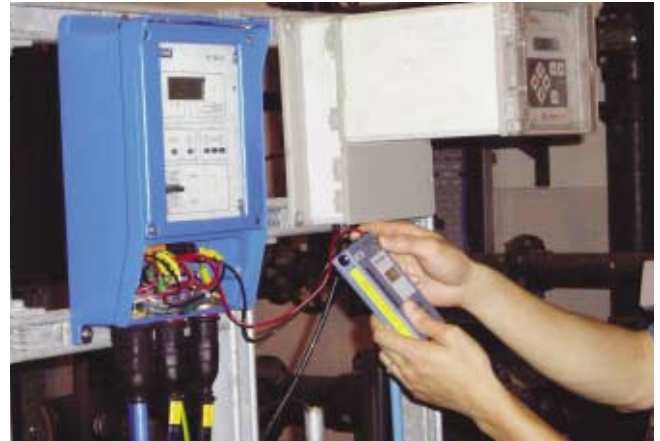
電磁流量計調校中。
An electromagnetic flowmeter being calibrated.

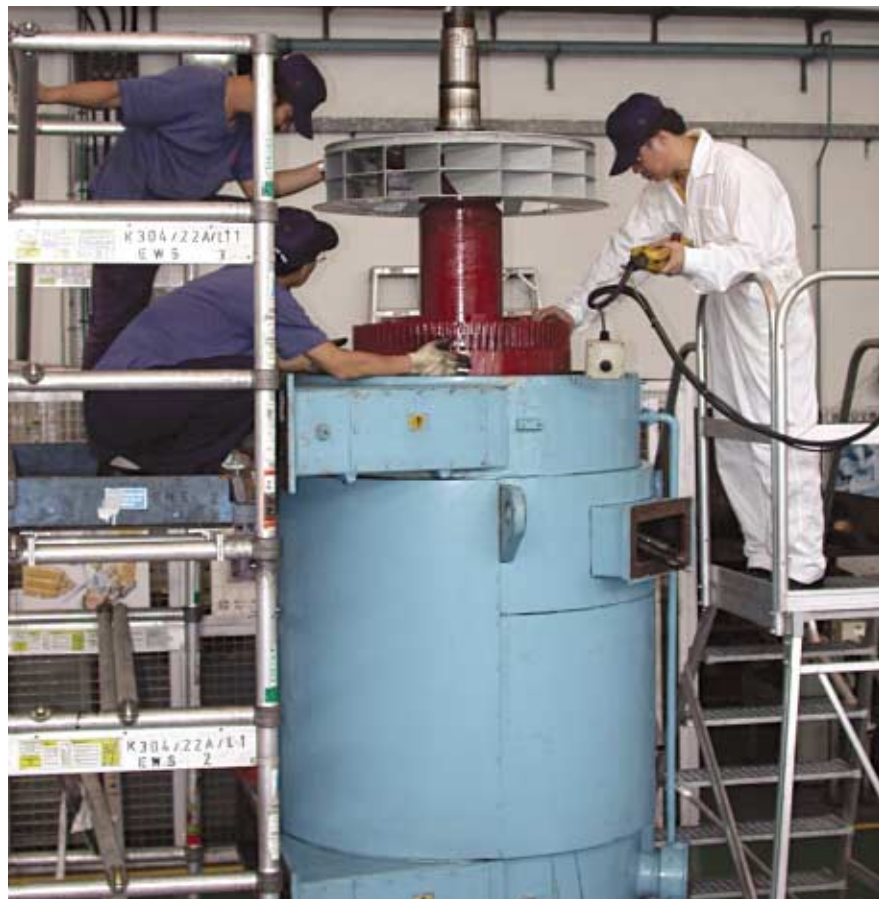
技術人員於電機工場內維修一座大型電動機。
A large electric motor being overhauled in Electrical Workshop.

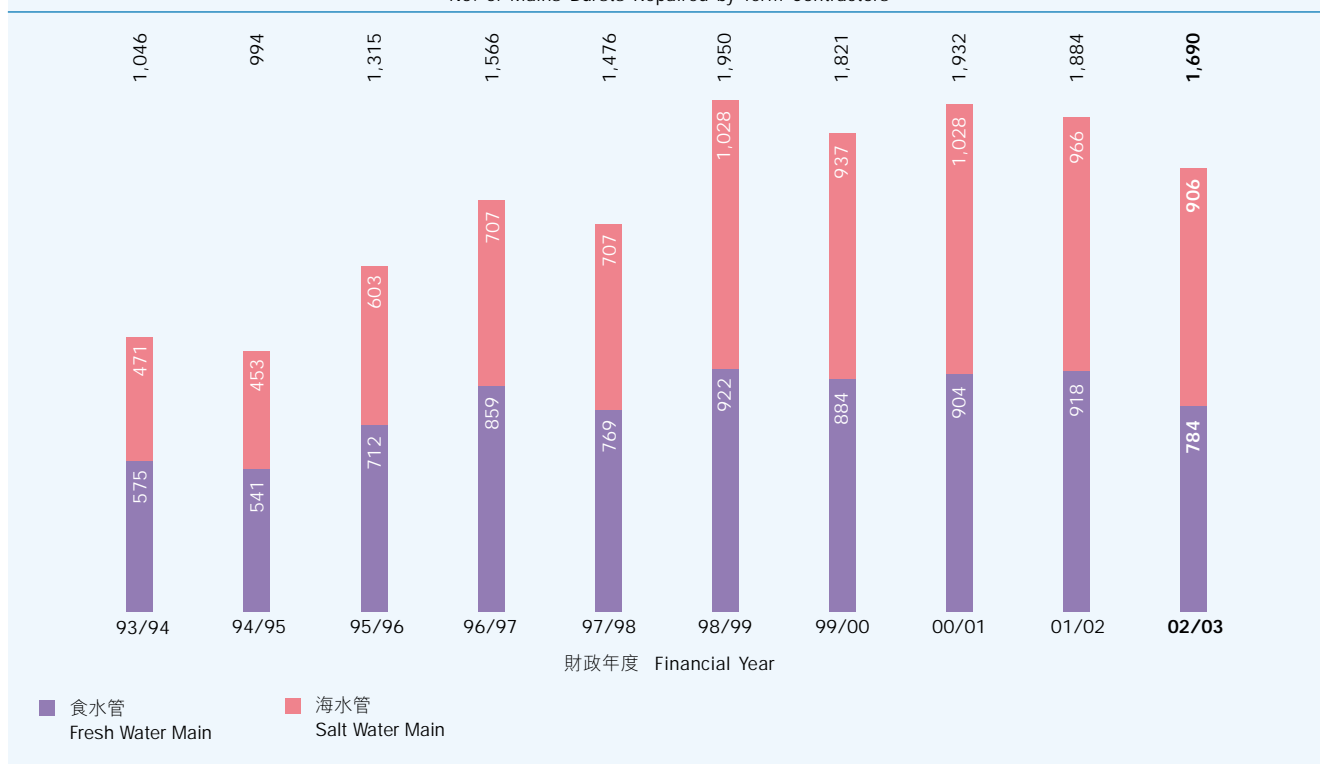
水管爆裂修理個案統計數字 (按供水類別劃分) Statistics on Mains Bursts Repaired (By Types of Water Supply)

由定期合約承辦商修理的水管爆裂個案數目
No. of Mains Bursts Repaired by Term Contractors

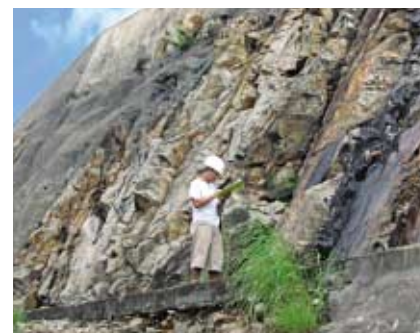
工作人員正進行斜坡安全檢查。
Staff carrying out slope safety inspection.

The safety inspections of around 6 000 slopes allocated to WSD have been contracted out to consultants. The first cycle of inspections has been completed and the information collected formed a useful basis for prioritizing slope maintenance work.

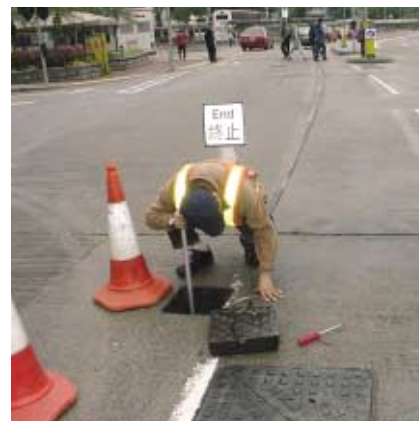
技術人員利用聽漏棍找出地下水管滲漏的位置。
Skilled staff using listening stick to detect leaks of underground water mains.

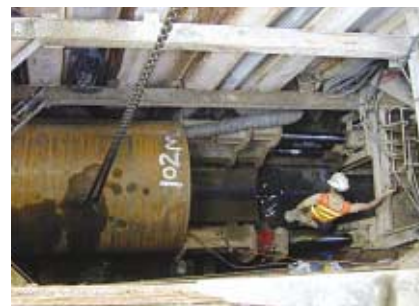
採用水管推頂方法於交通繁忙的道路敷設地下水管。
Using pipe jacking method to lay new water mains under busy road.
